New York City Office Building Saves 16 Inch Refrigeration Pipe with METALCLAD DuraWrap

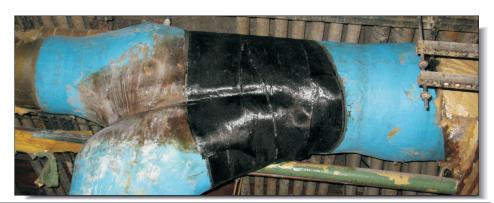
The leak had developed near an older repair close to the 'Y' connection on the header. Since the building provides cooling all year round, it does not have the luxury of shutting down its chillers to take the pipe out of service for an extended period of time.

After identifying the exact location of the leak, the area was prepared by abrading the surface. *DurAlloy* and multiple layers of

reinforcement cloth were then used to make the repair.

The pipe was then primed using the *DuraWrap Primer*. The carbon fiber fabric was throughly 'wettedout' with the *DuraWrap Polymer* and then applied to the pipe.
