## Waste Water Treatment Facility Repairs 30-Year-Old Pipe with DuraWrap Carbon Fiber Pipe Wrap System

**Client:** Waste water treatment facility

**Location:** Mid-Atlantic Region of the U.S.

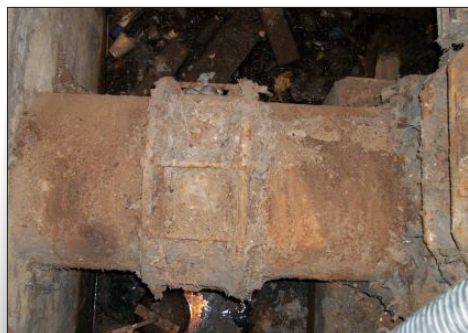
**Problem:** Leaking 30-year-old sewage intake pipe.

The Problem

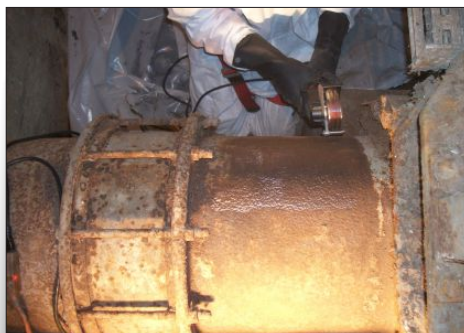
Surface Prep.

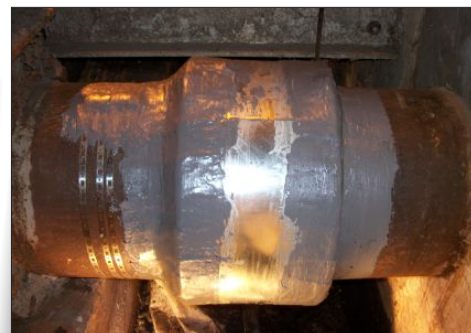
DurAlloy Repairs

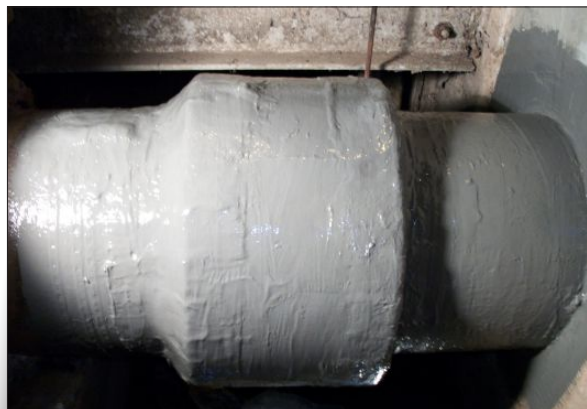
DuraWrap Primer

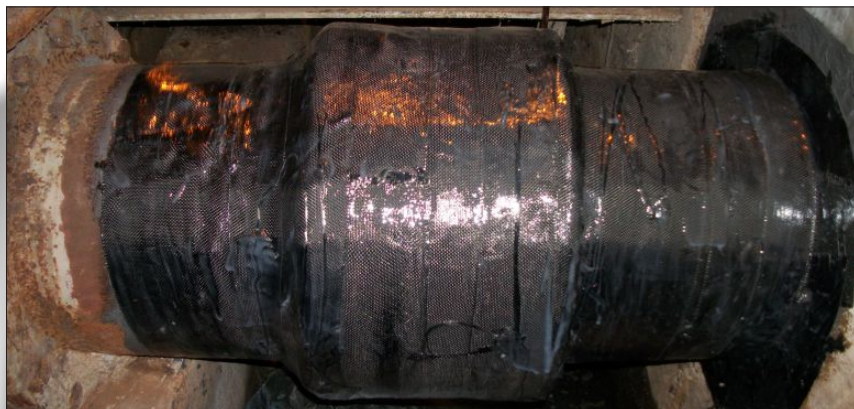
Finished DuraWrap System
