Power Plant Salvages One Million Gallon Tank With DurAlloy, CHEMCLAD & FLEXICLAD

Located at a Pennsylvania power plant, this sixty-five foot diameter, one million gallon tank was sitting dormant for many years and had severely corroded.

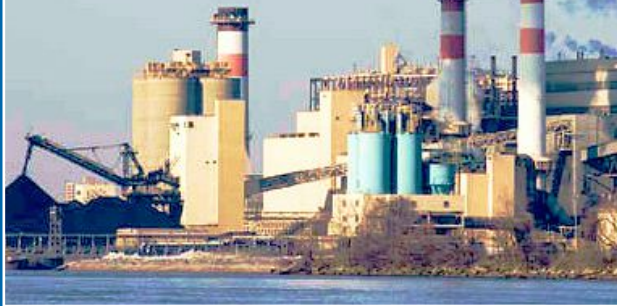
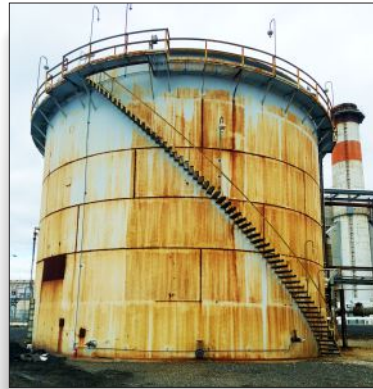
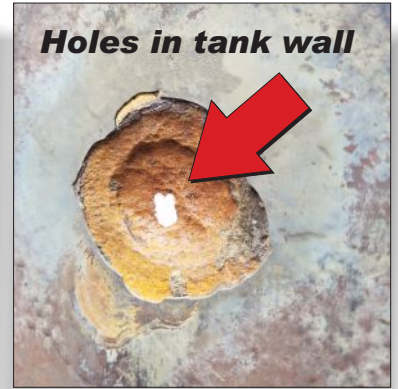
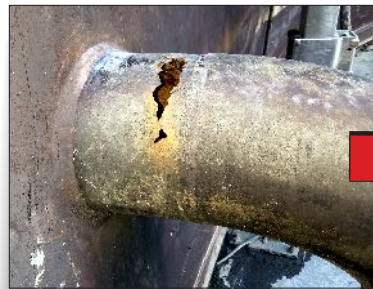
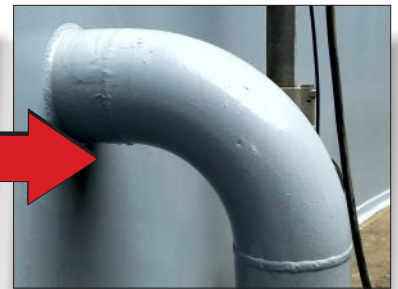
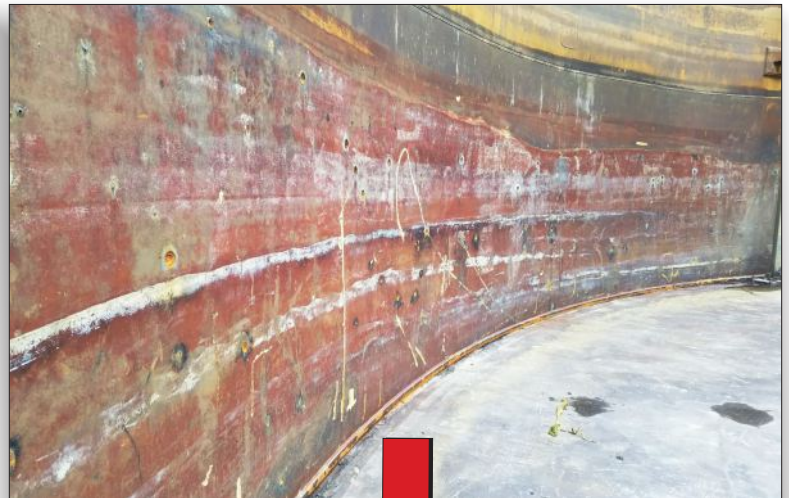
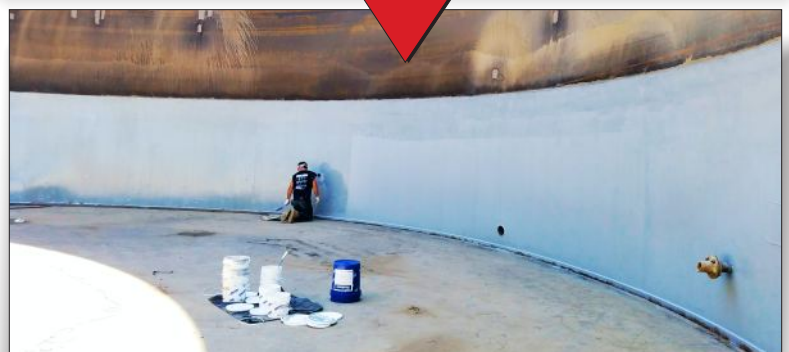
There were holes in the tank walls and piping as well as leaks through the floor / wall seams. The lack of any regular maintenance had rendered this tank unusable.

The existing coating was grit blasted off the tank walls eight feet high and all of the failed caulk from the floor / wall seam was removed.

The holes were repaired using *METALCLAD DurAlloy*. The walls then received two coats of *CHEMCLAD SC*. Once the *CHEMCLAD* was cured the entire floor / wall seam was sealed with *FLEXICLAD PC*.
