## Leaky Electrical Cabinets In Tennessee Are Protected With ENESEAL CR

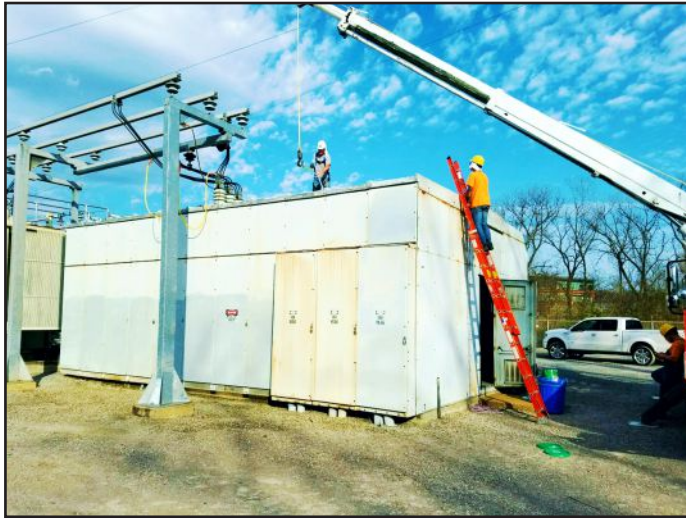
A Tennessee electrical utility was experiencing leaks in electrical cabinets in several locations across the state. When rainwater gets into these cabinets and on to the critical equipment inside, the equipment shuts down.

Because of limitations on pressure washing, the cabinet roofs were wiped down with degreaser. The cabinet walls were able to be pressure washed.

The seams were covered with a special roofing seam tape. Then two coats of ENESEAL CR were applied by roller to the roof. Two coats of ENESEAL CR were then spray-applied to the cabinet walls.
