Aviation Fuel Storage Tank In Romania Protected With ENESEAL & CHEMCLAD

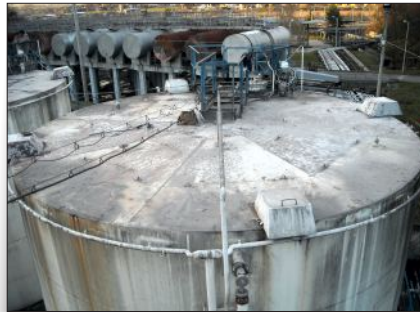
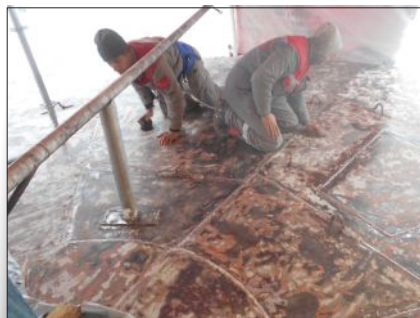
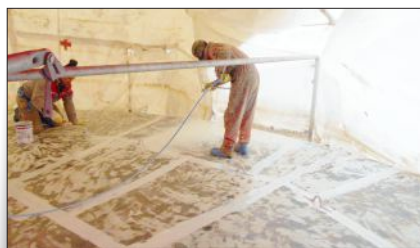
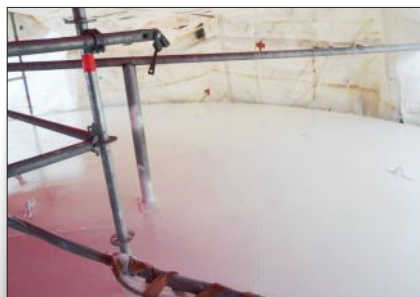
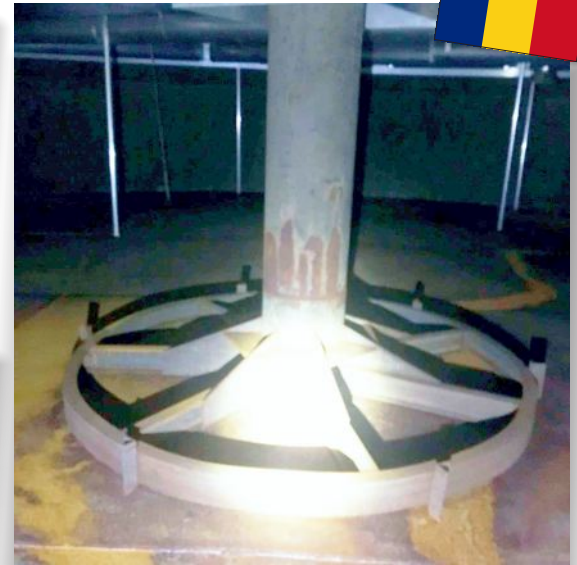
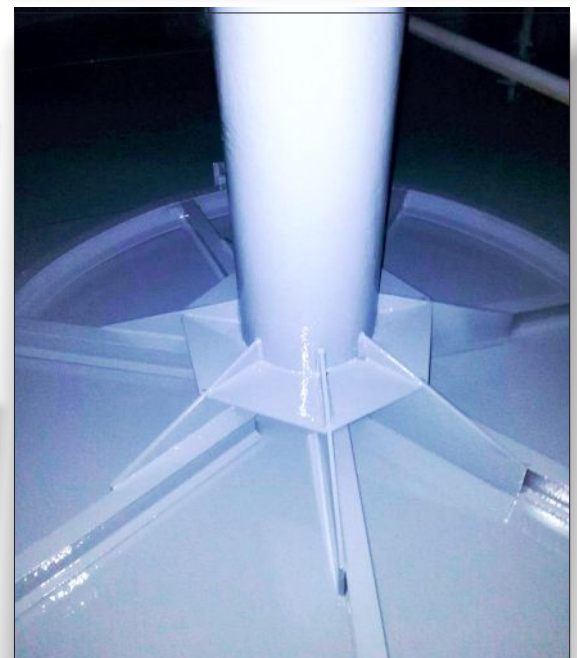
This large aviation fuel storage tank located in Romania was badly corroded. The aluminum top of the tank corroded over time due to many years of environmental exposure. The inside of the tank, exposed to the corrosive aviation fuel, had been previously protected with a coating. The original coating failed, causing the tank interior to be corroded as well.

The tank top was first mechanically prepared and sanded by hand. The weld seams were then stripe-coated with ENESEAL HR. This was followed by two sprayed coats of ENESEAL HR over the entire top area.

After making some small repairs to the inside of the tank, the area was grit blasted to the required SA 3 roughness. CHEMCLAD SC was then applied to a thickness of 200 microns (8 mils).
