## ELECON® NEWS

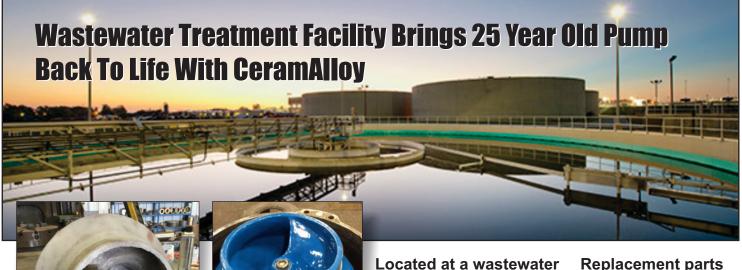
treatment facility, this

the scrap yard.

impeller from a 25 year

old pump was headed to

Replacement parts for the pump were obsolete and the city was considering replacing the pump for \$12,000+ and 8 weeks of downtime.

After grit blasting the impeller and minimal welding, the veins were rebuilt with CeramAlloy CP+AC. Followed by 2 coats of CeramAlloy CL+AC.

This repair and protection application only took 1 week to complete and the total cost for material and labor was less than \$4,000.
