One of the Largest Fertilizer Plants in Romania Salvages Broken Wastewater Pipe Saving Tens-of-Thousands of Dollars

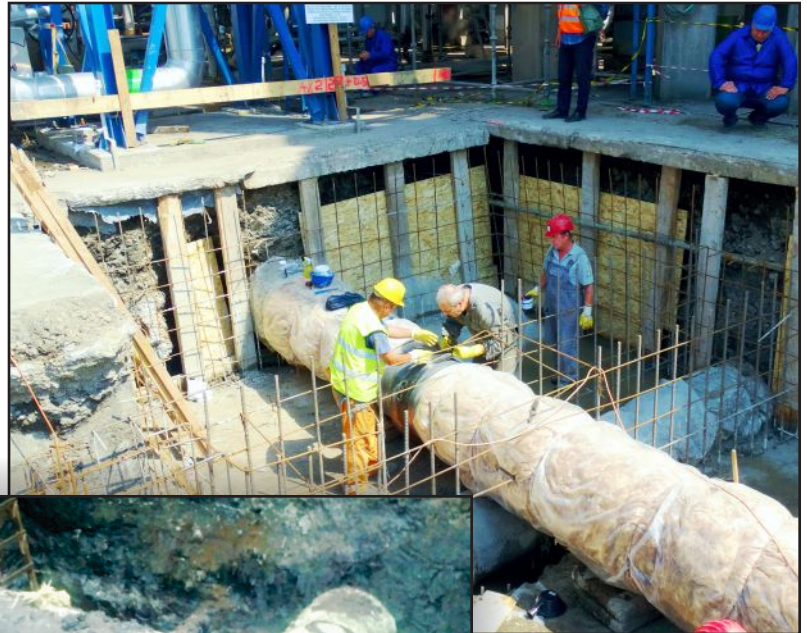
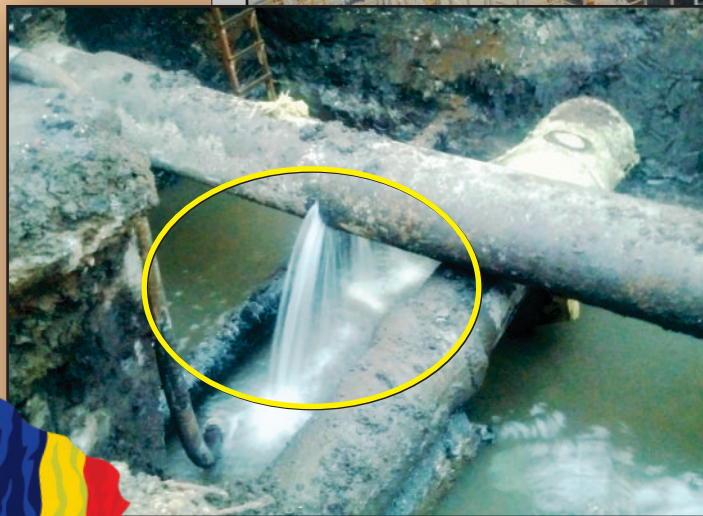
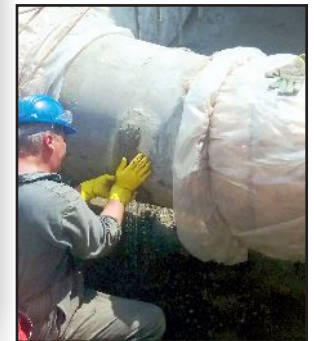
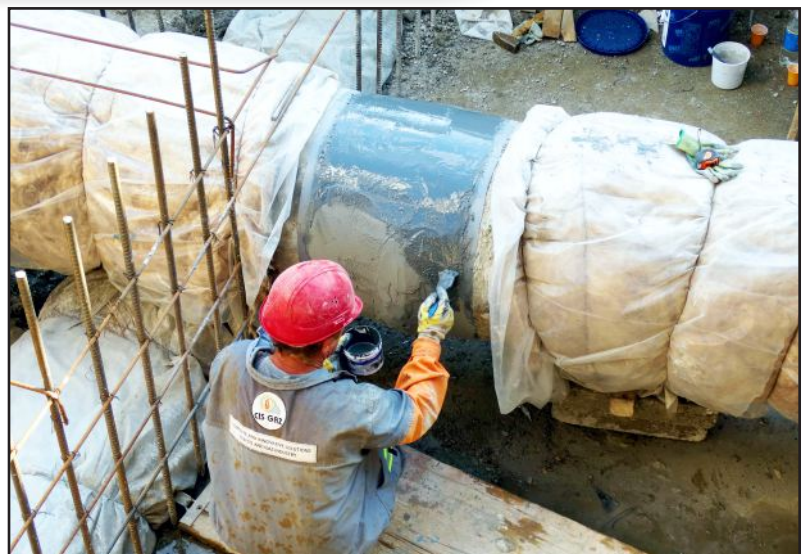
These two severely broken concrete pipes at a major fertilizer plant in Romania were leaking wastewater. This area was of great concern to the plant engineers because a foundation for some new equipment had to be constructed there.

ENECRETE WP was used to stop the leaks followed by the installation of a *DuraWrap* carbon fiber system. *DuraQuartz* was then used to build up the thickness to match the diameter of the concrete pipe, followed by a coat of *CeramAlloy CL+AC* for good measure.
