## DuraWrap Repairs 24 Inch Force Main Pipe At Florida Wastewater Treatment Plant

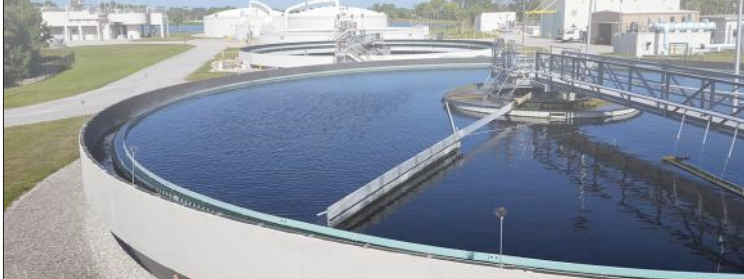
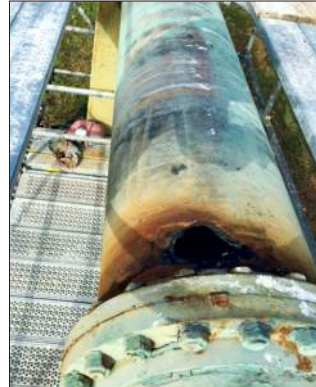
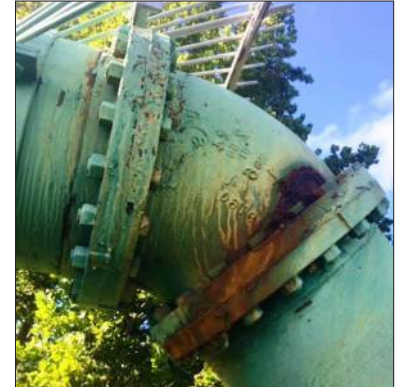
A major central Florida wastewater treatment plant had severe corrosion on a 24 inch force main pipe that could not be taken out of service. Replacing the pipe was not an option. It had to be repaired while it was still in service.

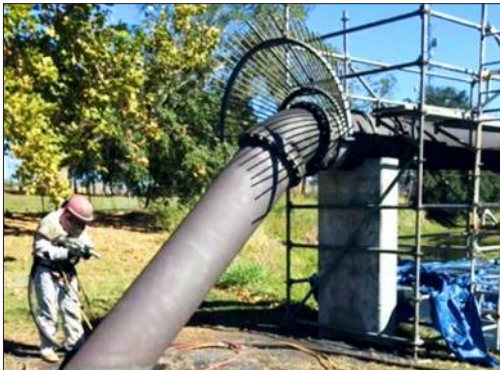
Grit blasting

The pipe was first grit blasted to remove old coatings, surface corrosion and provide the needed profile. All visible holes were repaired with DurAlloy. The largest hole was repaired

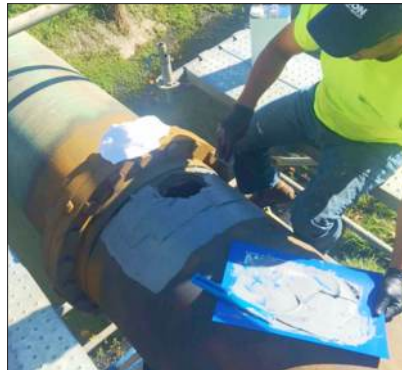
Applying DurAlloy

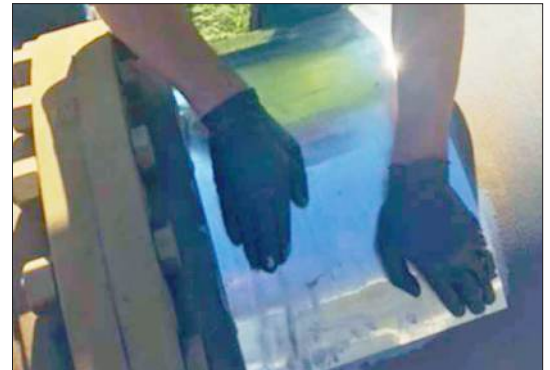
Bonding the stainless steel plate

by applying DurAlloy to the area around the hole then bonding a piece of stainless steel in place over it.

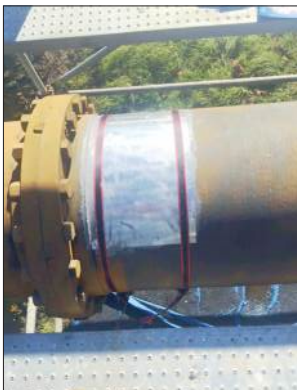
Tension straps

Tension straps were placed around the steel and pipe for 24 hours to ensure a proper fit for the repair.

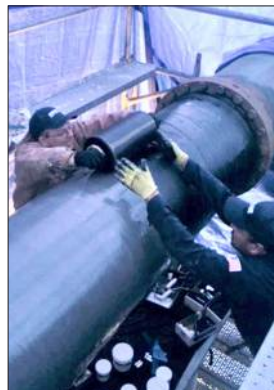
Carbon fiber pipe wrap

the edges of the repair. DuraWrap primer was applied to the pipe. Then 12 inch wide carbon fiber was wrapped around the pipe and wetted out at the same time.

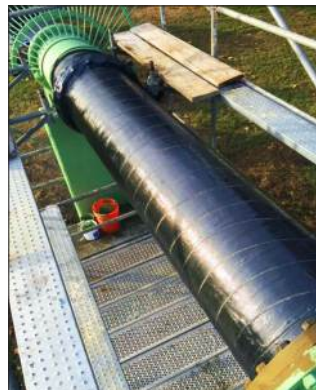
Finished repair

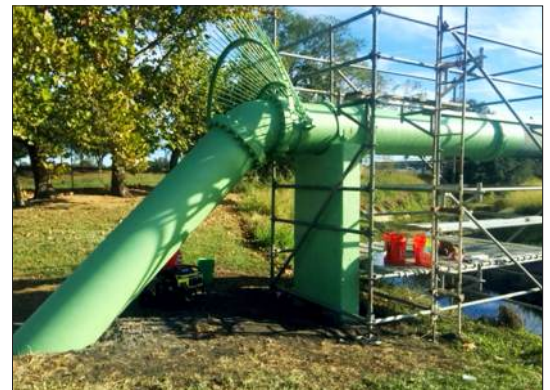
ENESEAL CR

A final top coat of ENESEAL CR green was then applied for corrosion resistance and aesthetics.
