CeramAlloy CBX Lasts For 4 Years & Outperforms Rubber Liner Inside Submersible Pump

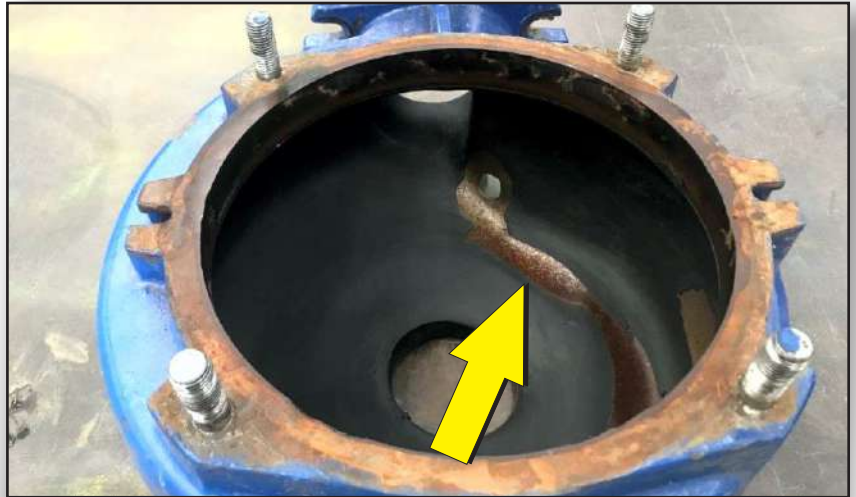
After 8 months of pumping effluent, sand and gravel from an Australian commercial dairy farm, the rubber liner failed. The casing developed holes and was taken out of service.

Failed rubber liner after 8 months

A trial application of ENECON's *METALCLAD CeramAlloy CBX* was completed to assess its abrasion resistance and ability to perform in aggressive abrasive environments.

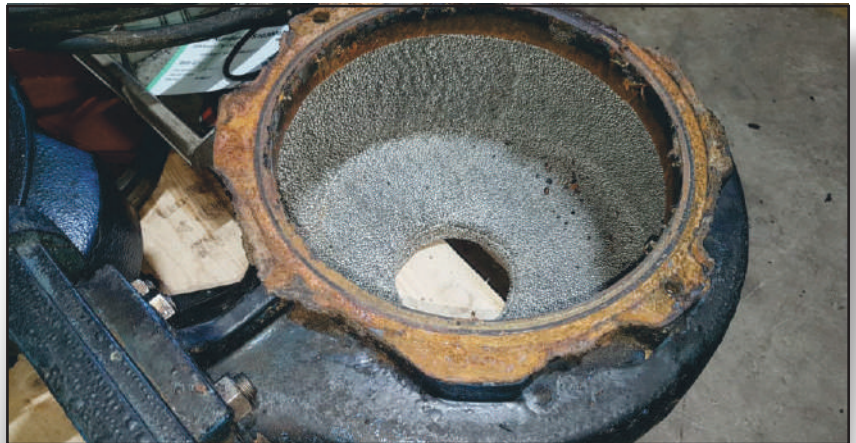
After a period of 4 years the *CeramAlloy CBX* was still in excellent condition. No maintenance was required and the pump was returned to service.

After 4 years in service

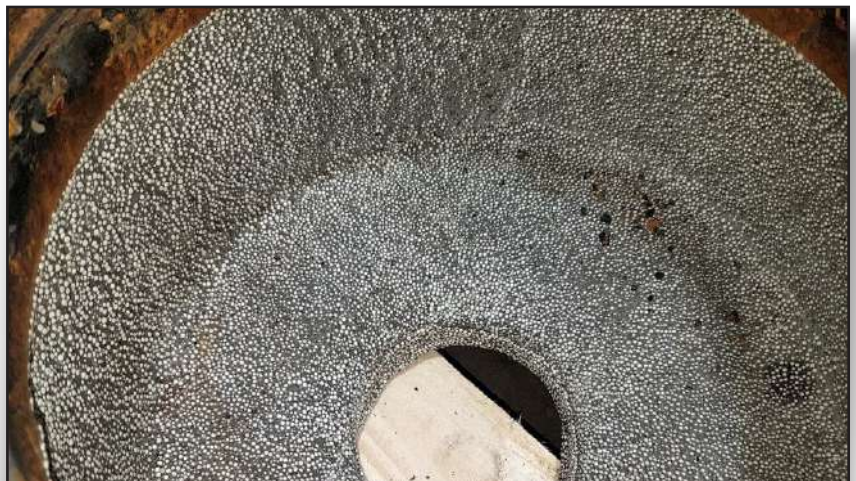
CBX looks like new!
