Loose concrete was chiseled out and removed and then the floor surface was cleaned. DuraFill mixed with locally sourced aggregate was 40 Years Of Chemical Attack At Pennsylvania Juice Factory Is Eliminated With CHEMCLAD & DuraFill

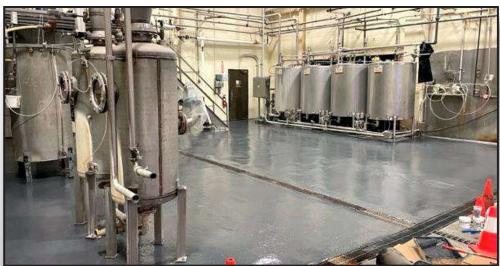
Years of constant acid attack on this 40-year-old floor at a juice processing plant in Pennsylvania caused severe erosion damage to the concrete. The local ENECON District Sales Manager was called in to provide a solution.

applied to repair the damaged areas.

Two coats of CHEMCLAD GP and CHEMCLAD XC were applied in specified areas to provide protection to the floor from the constant exposure to various acids and chemicals.
