## Clarifier Tank Rim Repaired With DuraFill

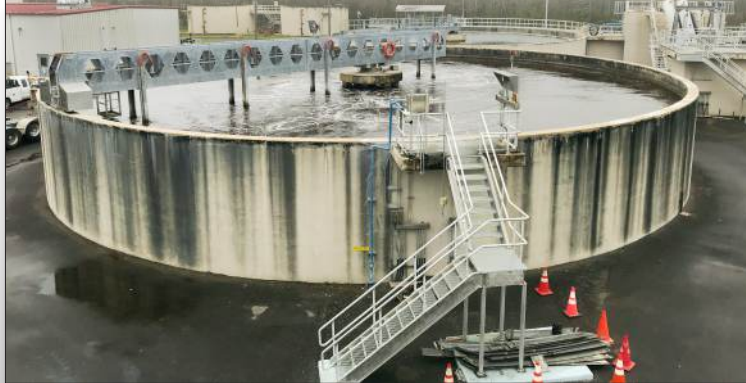
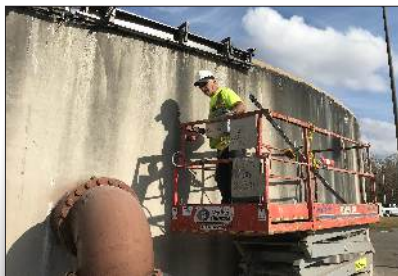
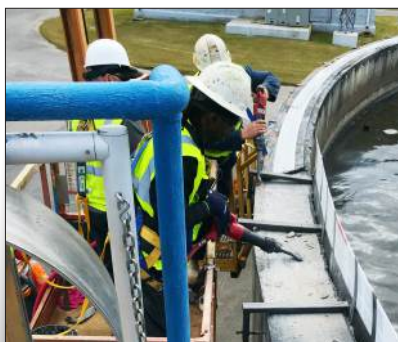
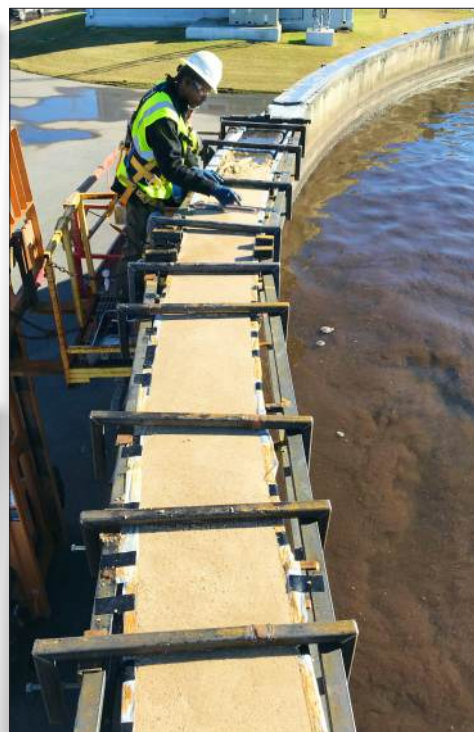
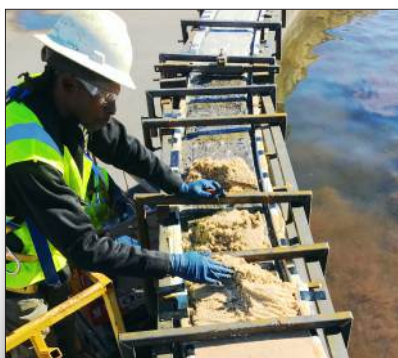
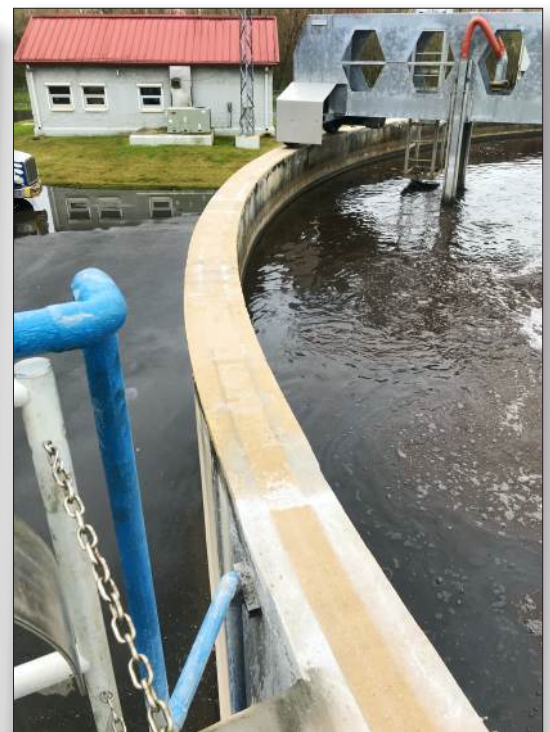
The steel plating on this clarifier tank rim, which serves as a track for the tank's scraping bridge wheels, had been in service for 15 years. Located at a Southern Louisiana wastewater treatment facility, the bridge makes approximately one full rotation every minute.

The plating weld seams began breaking causing the concrete underneath it to also break. The bridge wheels were being damaged as a result of the broken concrete.

cost effective solution. The plating was detached and any loose or crumbling concrete was removed using an air chisel hammer. A former was constructed and clamped to the tank rim to prevent concrete from falling into the tank.

DuraFill was mixed with a locally sourced silica quartz sand and applied to the tank's rim. The former also allowed the applicators to keep the DuraFill level during application. The entire project only used 5 units of DuraFill, but it saved the maintenance team at the plant tens-of-thousands of dollars.
