METALCLAD & CHEMCLAD Fight Corrosion on Northern California Wastewater Treatment Facility Vacuum Truck Tank

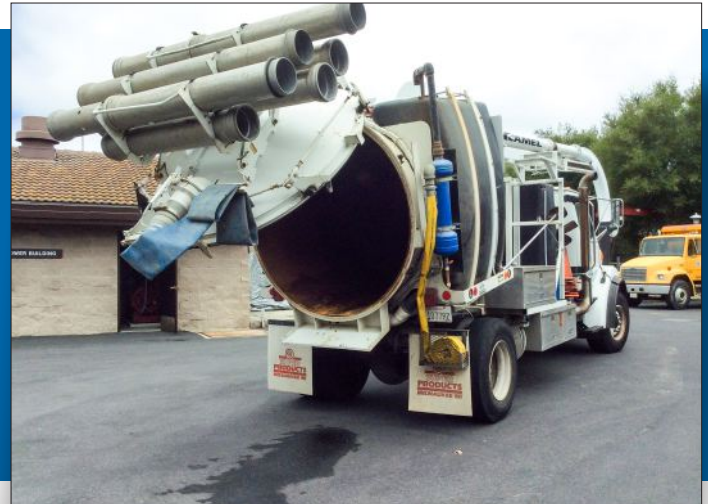
After years of use, this Northern California wastewater treatment facility vacuum truck was suffering from extreme corrosion.

The local ENECON Field Engineering Specialist was called in to provide a long term solution to this problem, a problem that almost every vacuum truck experiences in this industry.
