FLEXICLAD ER[®] Repairs Rubber Covered Drive Shaft at Wastewater Treatment Facility

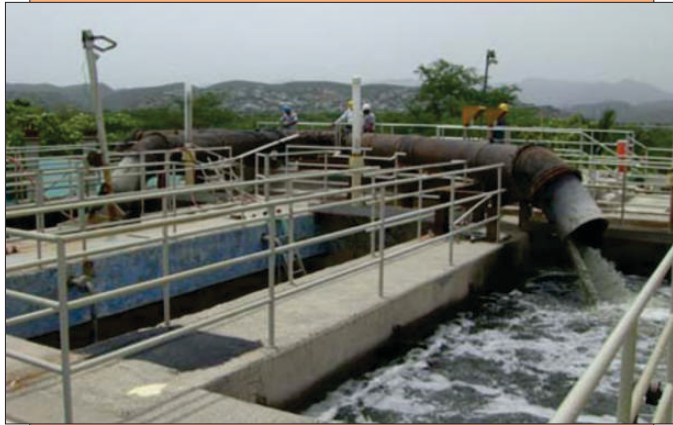
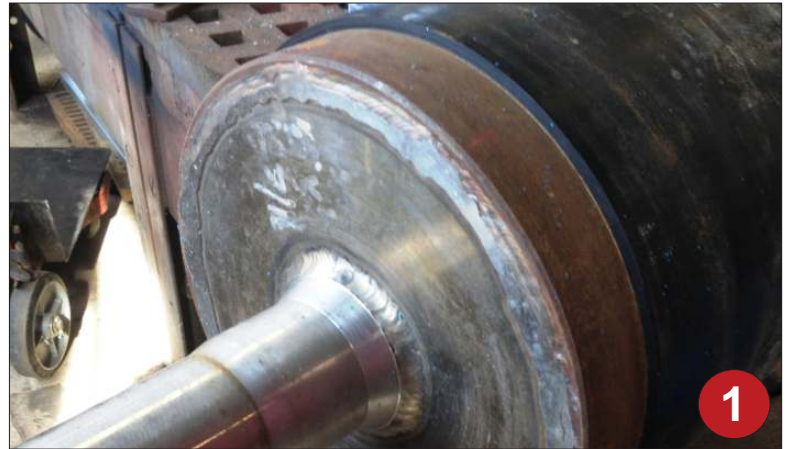
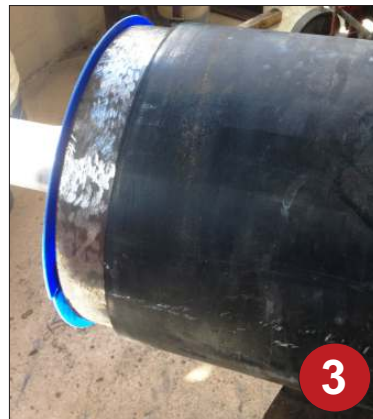
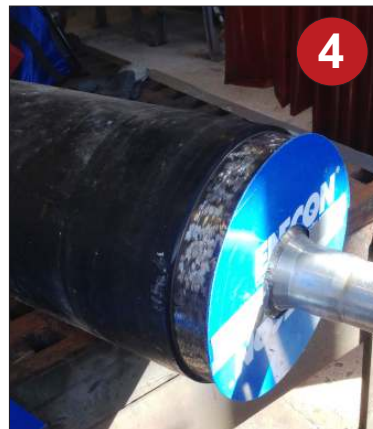
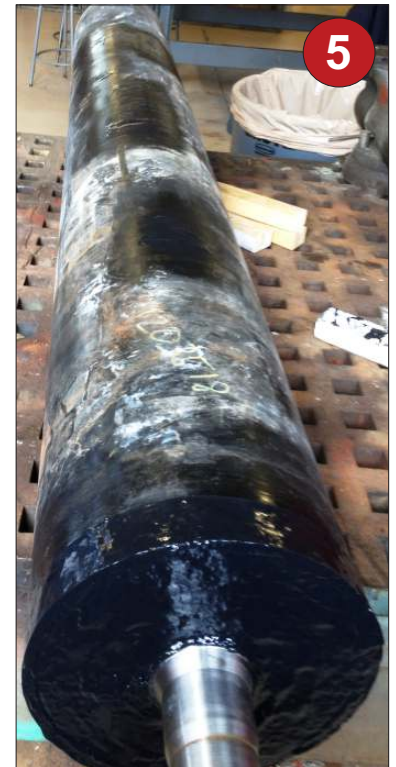
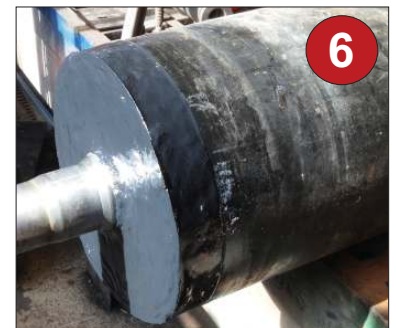
The end of this 10 inch diameter drive shaft, used on the belt system for de-watering the 'floc' at this wastewater treatment facility, had to undergo some welding repairs. The existing rubber shaft covering had to be cut back to allow for the welding process.

The plant engineers needed to get the system running so they turned to their local ENECON Field Engineering Specialist for help. He suggested using FLEXICLAD ER to rebuild the exposed end – providing a seamless rubber finish on the shaft.

A plastic former was created (an ENECON mixing board was used for this) to help in the rebuilding process. After grinding the metal, a ¼ inch of FLEXICLAD ER was applied to re-finish the shaft end. After 30 minutes, the former was removed and more FLEXICLAD ER was applied to complete the repair on the exposed end of the shaft.

This entire project was successfully completed in just one day saving the plant thousands of dollars in down-time associated with conventional rubber repairs which would have taken 3+ weeks.
