Skyscraper Cooling Tower Corrosion Problems...No Match for CHEMCLAD!

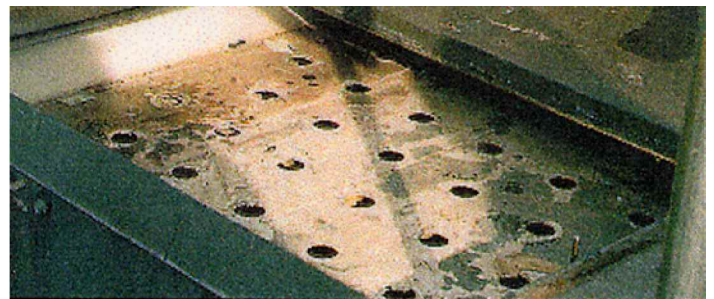
The most recent attempt at solving the corrosion problem was to coat the units with a pool paint in order to protect the galvanized metal pans. The coating lasted only a few months and then began to peel -- creating even more

Pool paint peeling on pans poses problems.

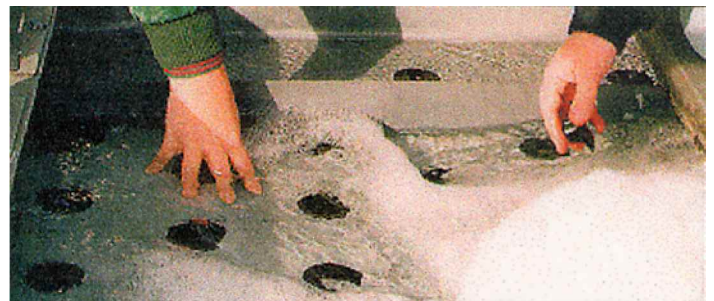
Problems solved & pans protected with CHEMCLAD SC.

Due to the cold weather, the entire area had to be covered with tarpaulins and heated. Then the ENECON Team, hoisted compressors, blasting equipment and supplies to the roof -- some 60 stories high -- and completed this \$10,000 project in just a few days.
