ENECRETE DuraQuartz Conquers Critical Concrete Problems

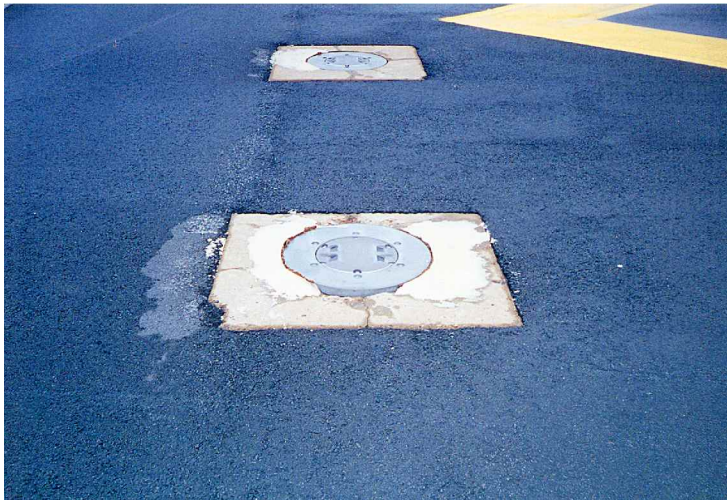
These concrete pads for these airport runway lights were badly deteriorated from service conditions subjecting them to freeze/thaw cycles, de-icing salts and mechanical damage.

engineers knew that they would not have time to enable them to carry out all the repairs at once. They were, therefore, quite pleased that the DuraQuartz could be mixed in unit quantities to allow for the repair of as few - or as many - light pads as time allowed.

In addition, the fact that the DuraQuartz would bond to the concrete, as well as the light's metal holder/housing mounted in the concrete, proved additionally beneficial.

Matt proposed an idea he was certain would "fly" with the engineers...the use of **ENECRETE DuraQuartz**. A number of lights had to be repaired; but, the
