DuraQuartz Holds Up to TONS of Abuse...

Tons to be Exact.

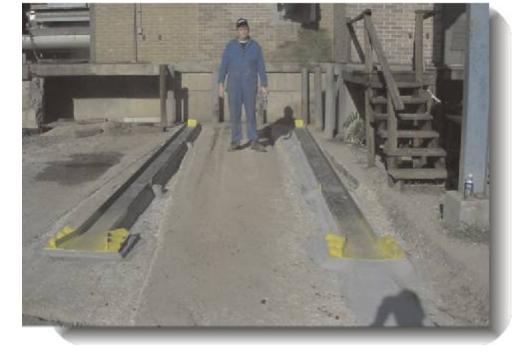
The plant maintenance engineers at this wastewater treatment facility located in Southeastern Pennsylvania had been living with a very severe concrete wear and erosion problem for many years. Twice each day, 16ton dumpsters were loaded with waste material and dragged along these concrete pads by the carting company eroding the concrete to the point that the dumpsters could no longer be moved effectively.

The plant engineers needed a cost effective yet quick repair solution because the plant operates 24/7 and the effluent could only be diverted for a maximum of 36 hours. They turned to their local ENECON Field Engineering Team for an "unconventional" approach to solving their problem. Carl Durham, ENECON's National Projects Manager, suggested fabricating steel channels and setting/anchoring these in place with ENECRETE DuraQuartz. ENECON's five-man crew installed 67 units of DuraQuartz to repair and level the deck while also bonding the newly fabricated steel rails permanently to the deck.

The entire procedure took just 8 hours to complete to the total satisfaction of the plant's engineers.
