ENECRETE WP & WS Solve Leaking Elevator Pit Problems for National Hotel Chain

The following story and pictures were supplied by ENECON's District Sales Manager based in San Diego, Camille Segobia. Her report reads as follows:

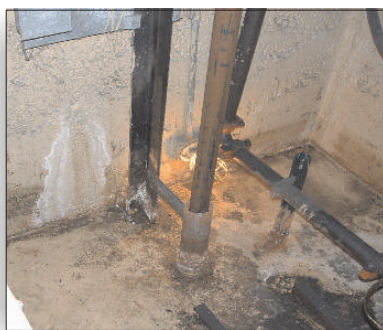
The project became very involved because there was a great deal of oil and a very thick existing coating that had been pushed deeply into

numerous crevices and holes in the concrete. It took 5 workers, 2 days to remove the existing coating using needle guns. The problem was so severe because the elevator pit was not made of cinder block, but instead, it was a poured concrete pit - poured in 3 sections allowing gaps and crevices to form between each pour.

Elevator Pit Before

We used 2 units of ENECRETE WP and 8 units of ENECRETE WS, coating four feet up the pit walls.

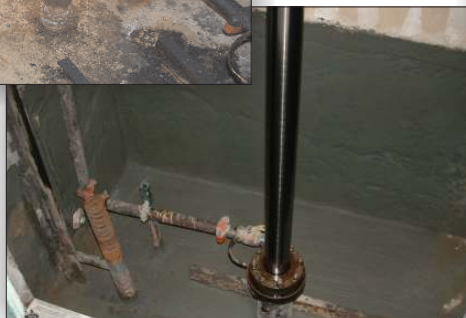
After

The project was completed on time. The client and the State inspector were both very pleased with the results."

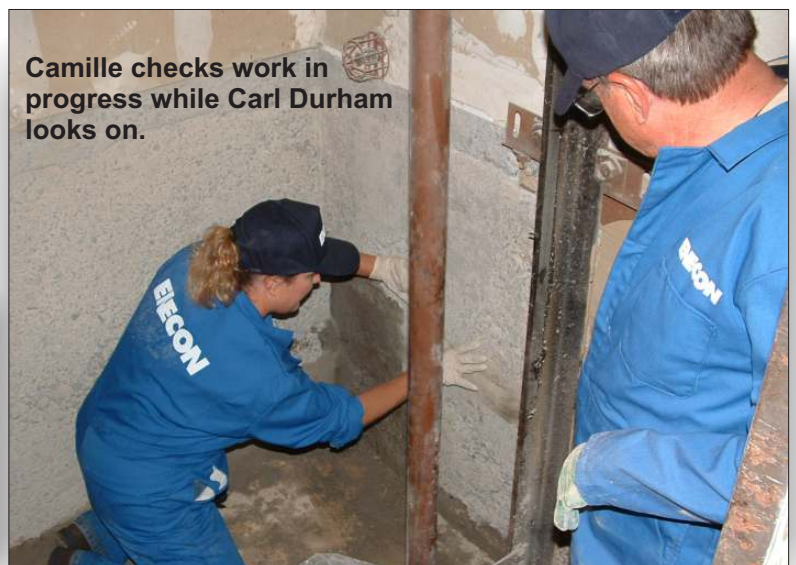
Camille checks work in progress while Carl Durham looks on.
