Spanish Nuclear Plant Repairs and Protects Secondary Containment Areas with DuraQuartz and CHEMCLAD

EC-031

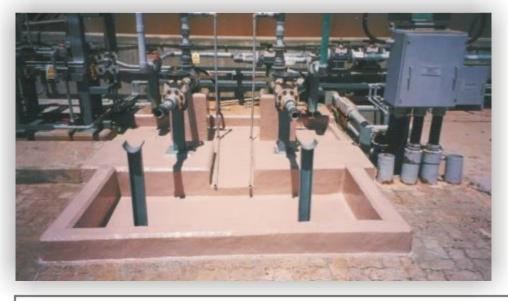
NOTE: This application has now provided the plant with outstanding performance for over seven years!

This would be followed by a two-coat application of *CHEMCLAD SC* (gray+tan) to provide long-term protection to the containment areas.
