FRECON® NEVS

at Costa Rican Beer Manufacturer

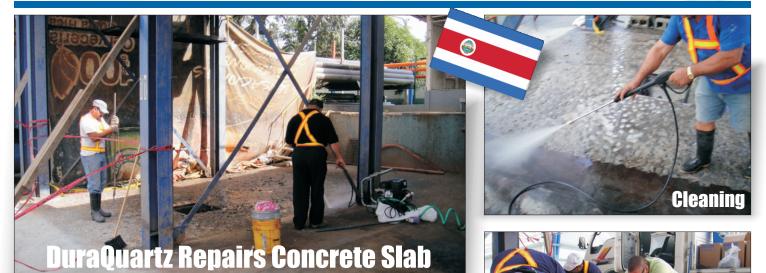
At one of the largest beer manufacturers in Costa Rica, the maintenance engineers were experiencing severe erosion and corrosion on a large concrete slab.

After many years of heavy truck traffic and corrosive

material spillage, this area had become pitted and severely deteriorated.

After removing any loose debris, the entire area was power washed.

Over 18 units of **DuraQuartz** were then used to repair the damaged area and provide excellent protection from future abuse.

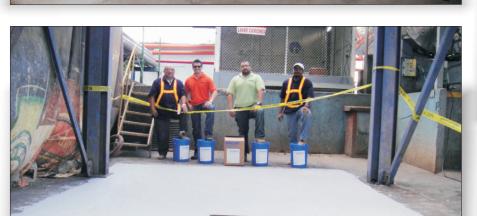
The crew admires a job well done!

ing DuraQuartz
