Ceramics Factory Roof in the Philippines Repaired & Protected With ENESEAL HR

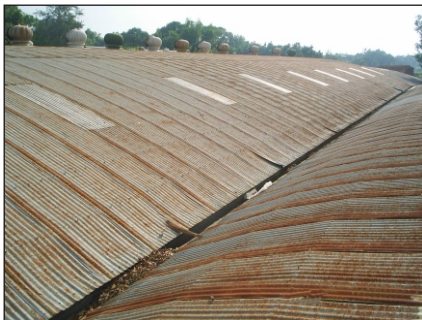
This ceramics factory, located near Manila, had a badly corroded metal roof with hundreds of holes in it. Water would drip all over the factory during the rainy months. The factory workers would routinely squeeze into the sections of the factory where there was no water dripping!

Note the holes in roof.

After cleaning the roof, self-adhesive fiberglass mesh was applied over all the holes in the corrugated metal sheets. This was followed by a two-coat application of ENESEAL HR.
