ENESEAL CR Solves Serious Corrosion Issues at Major Canadian Grain Company

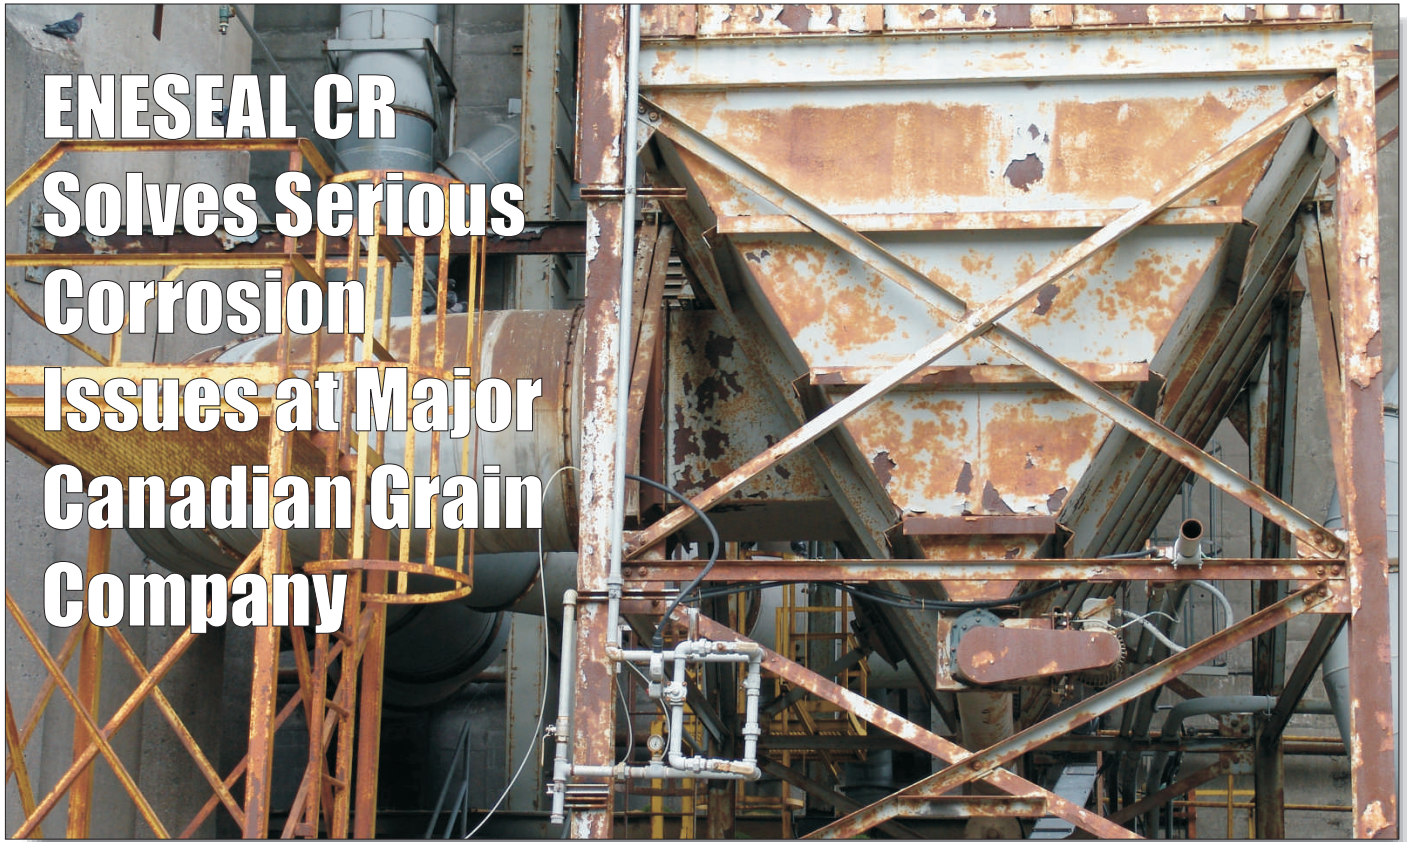
The conventional paint system on this dust collection equipment located at a large grain processing plant in Quebec had failed and was no longer providing corrosion protection to the steelwork. The plant's maintenance engineers were looking for a high performance, corrosion resistant coating system *that did not require grit blasting prior to its application.*

ENESEAL CR provided a cost effective solution. Because it is 'surface tolerant' only high pressure power washing

was utilized to clean and prepare the steel surfaces. Two coats of ENESEAL CR were then spray-applied to provide an aesthetically pleasing, corrosion resistant surface treatment.
