CeramAlloy Used for Critical Pump Repairs At Nuclear Station... Saves \$90,000 in Replacement Costs!

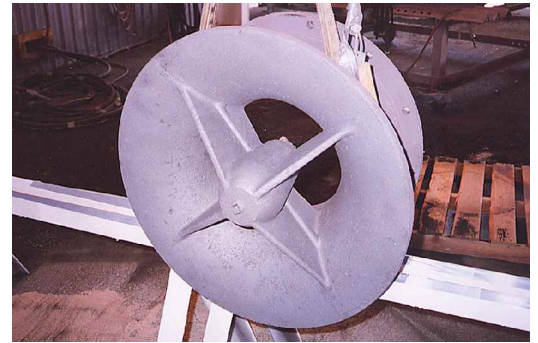
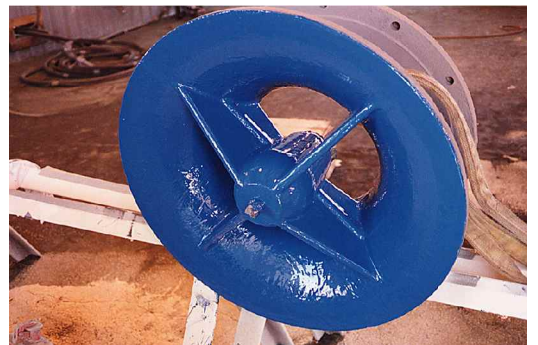
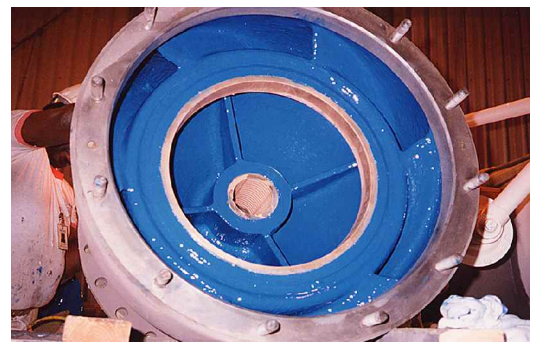
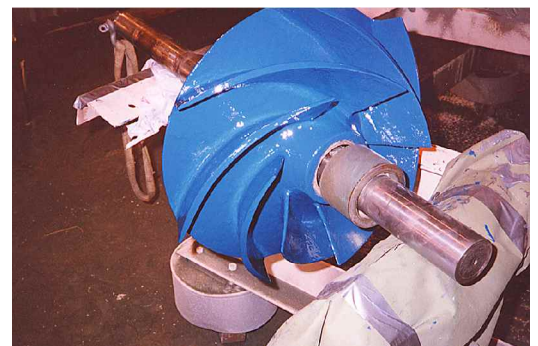
The plant engineers at a nuclear power station located in the Pacific Northwest in the US discovered severe erosion/corrosion wear on the impeller, the suction bell and the diffuser bowl of a large submersible pump. This tower make-up water pump supplies water from the river to the cooling towers.

Sand and silt entrained in the river water accelerated the erosion damage to the pump while electrolysis problems had also accelerated the corrosion damage.

All the pump components were first abrasive blasted to a 3-4 mil profile. All pitted areas on the diffuser bowl and the suction bell were then filled using CeramAlloy CP+ followed by the application of two coats of CeramAlloy CL+. The impeller, due to the rough surface, was coated with brush-applied CP+ to fill in as a base for the subsequent two coats of CL+.
