CeramAlloy Saves Down-Time & Aggravation for Power Plant Engineers

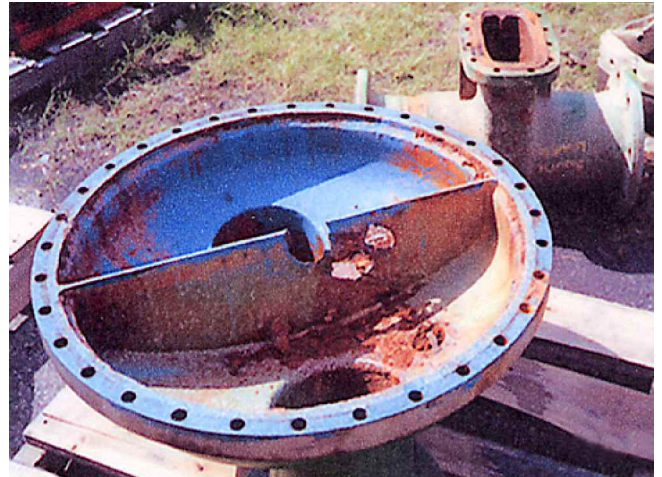
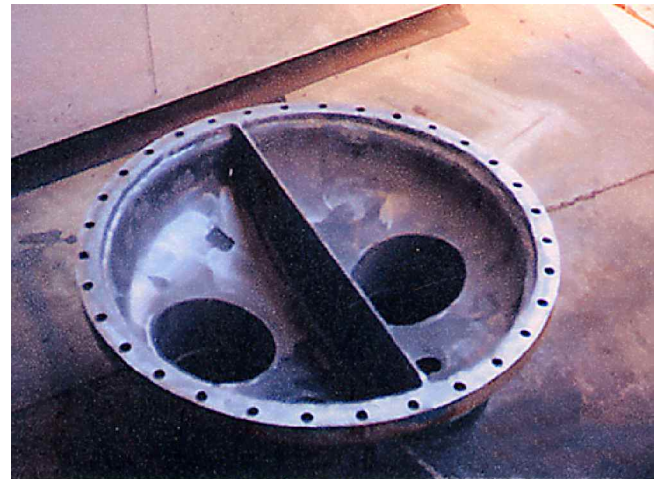
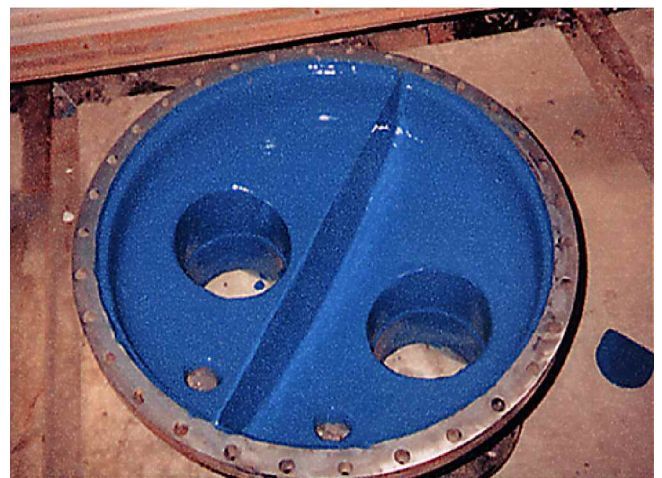
During the first weekend of a scheduled outage, this coal fired power plant in the southeastern United States discovered some extensive but unexpected damage to a number of heat exchanger components.

The rebuilding of the holed areas involved the use of metal screening and CeramAlloy CP+[AC] to bridge the gaps and build up the required thickness. After grinding the CP+[AC] to complete the system and protect the equipment from further erosion and corrosion.

The repaired components were returned to the plant on Friday and installed over the weekend - enabling the plant to be back in operation on Monday morning as originally planned.
