CeramAlloy Repairs and Protects Wicket Gates at Spanish Hydroelectric Power Station

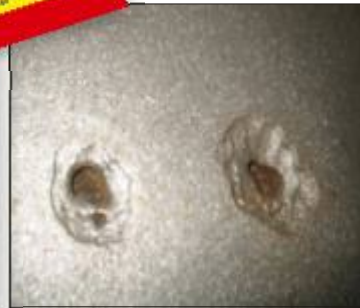
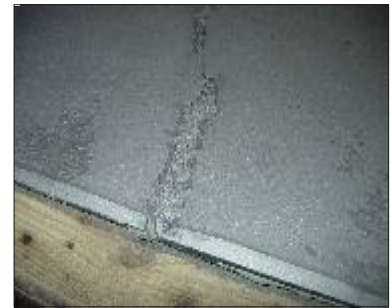
One of Spain's largest hydroelectric power stations was experiencing erosion and corrosion on its turbine wicket gates.

The station's engineers attempted to solve this problem by welding, but to no avail. Erosion damage was returning and deeper than before.

Upon review of the situation, it was recommended that the erosion damage (pitting) on the wicket gates be rebuilt with CeramAlloy CP+AC, followed by two coats of CeramAlloy CL+AC.

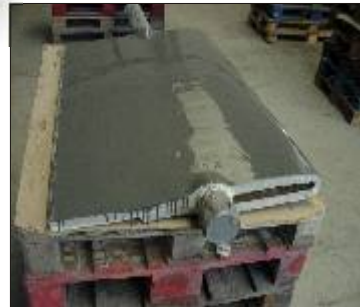
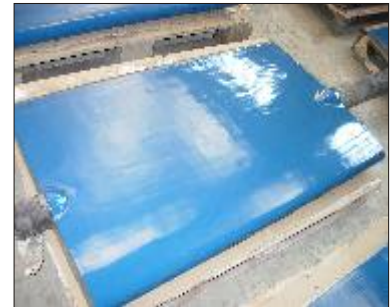
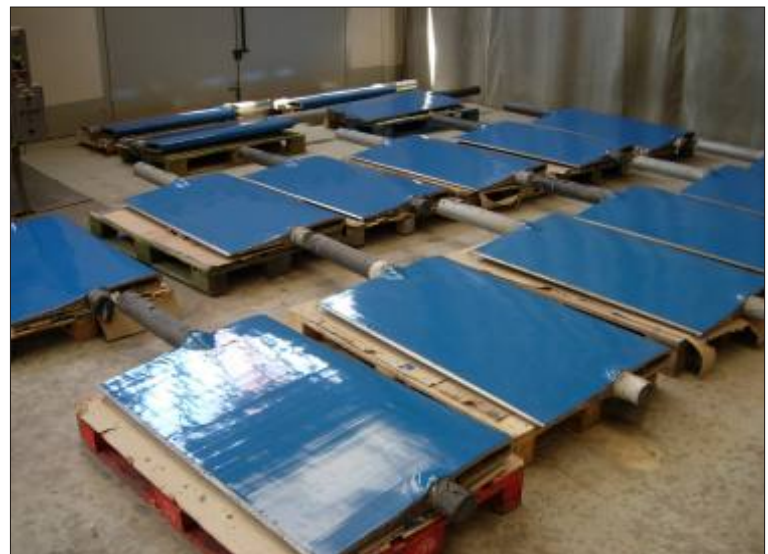
After the turbine wicket gates were repaired and resurfaced, the result was a smooth surface that is more erosion and corrosion resistant than the original metal.
