Francis Turbine at Spanish Hydroelectric Plant Repaired and Protected with CeramAlloy

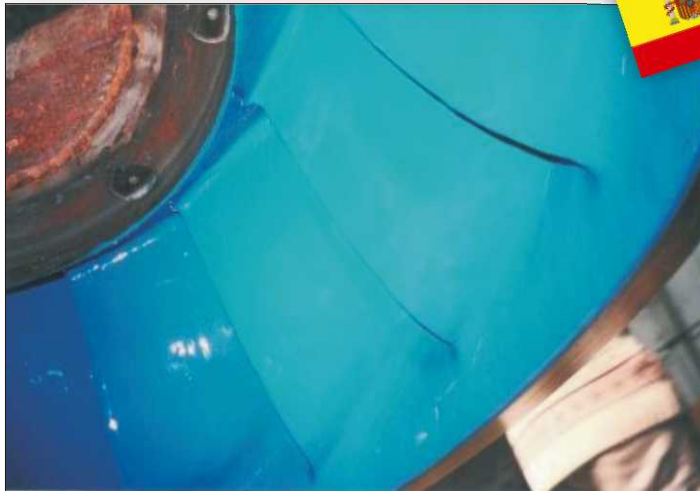
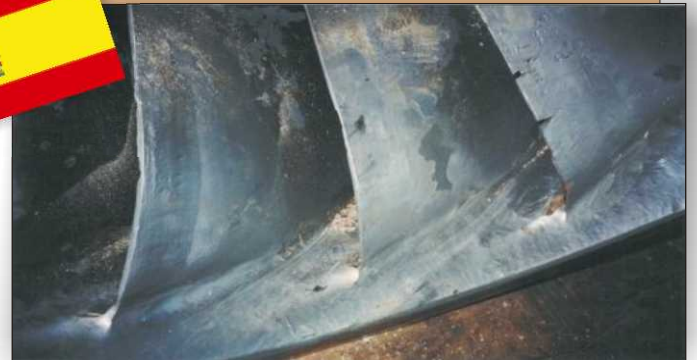
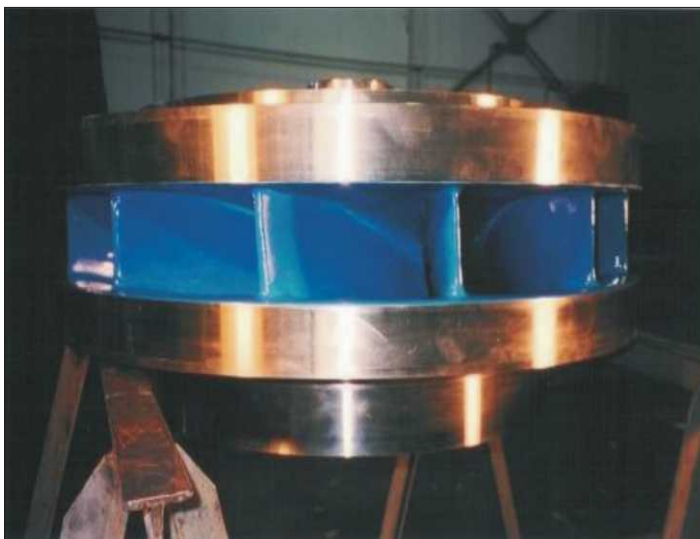
This Francis turbine at a Spanish Hydroelectric plant was only in operation for 3 years before it started showing erosion damage caused by sand in the water. This erosion was causing the turbine blades to become very thin which reportedly resulted in loss of power.

He recommended that METALCLAD CeramAlloy CP+AC be used to rebuild

the turbine blades. Two coats of METALCALD CeramAlloy CL+AC were then used to help protect the turbine blades from future erosion damage.

This turbine rotates at approximately 1,000 rpm. Now after 5 years the plant engineers have reported no further erosion or loss of power on this turbine.
