## Spanish Nuclear Plant Uses CeramAlloy to Repair & Protect Cooling Tower Pumps

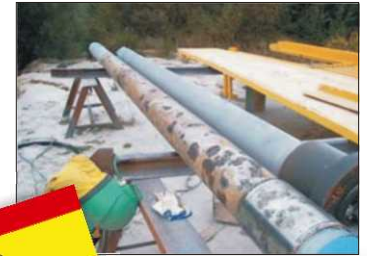
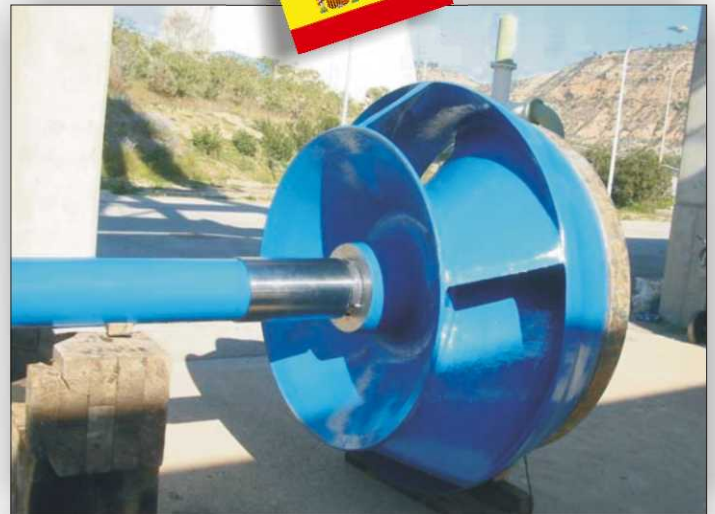
An important Nuclear plant in Spain had been experiencing erosion and corrosion on four pumps that supplied water to their cooling towers.

CeramAlloy CP+ was first applied to repair any damaged areas. That was then followed by an application of CeramAlloy CL+ for protection against further erosion and corrosion.

To repair the pumps the surfaces were grit blasted.

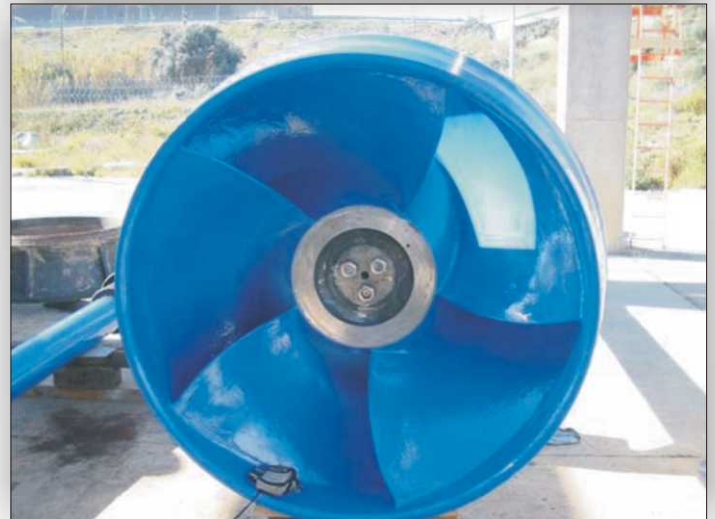
The plant engineers were so pleased with the outcome of the first pump and it's durability, they agreed to have the remaining 3 pumps repaired and protected. The recommended ENECON Ibérica solutions eliminated the need to replace the pumps, saving the plant thousands of Euros.
