California Power Plant Salvages Main Cooling Water Inlet Pipes with a CeramAlloy Pipe Wrap System

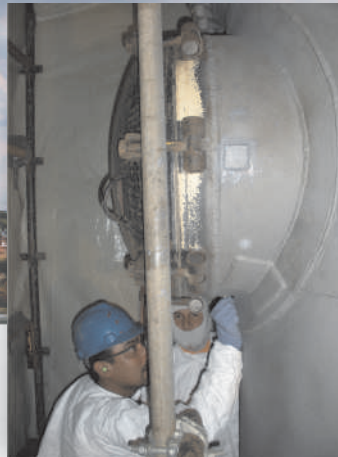
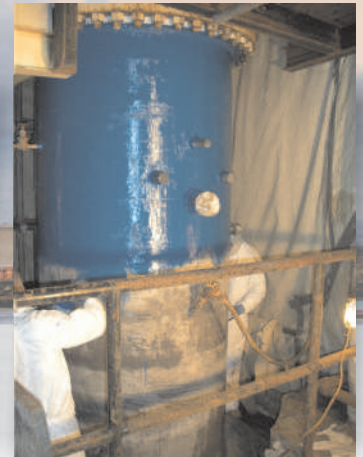
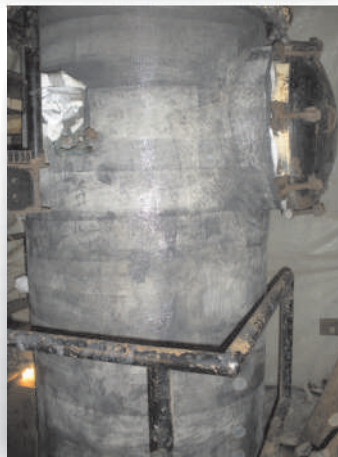
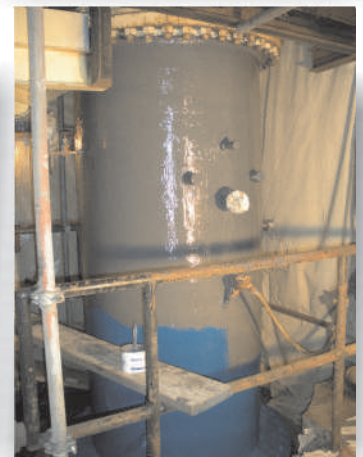
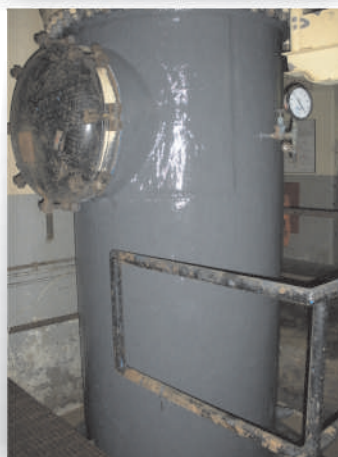
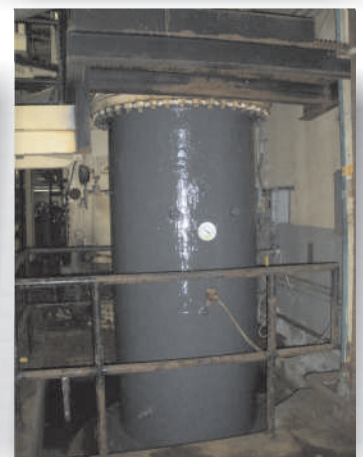
The engineers at this large power station in California identified a serious problem with their two main cooling water inlet pipes which were severely corroded due to many years of operation in a coastal marine environment.

After first grit-blasting these 4-foot diameter pipe sections, any serious corrosion

damage - including a number of actual holes in the pipes - was first repaired with DurAlloy and metal plates.

A layer of **CeramAlloy CL+AC** was then applied over the entire pipe section followed by a spiral wrap of a special reinforcement fabric. This was then completely encapsulated by an additional two layers of CeramAlloy CL+AC to complete the pipe wrap system.

This procedure was completed in just a few days and at a fraction of the cost that would have been incurred to replace these large pipe sections.
