MT-129

Power Plant in Thailand Uses CeramAlloy® and CHEMCLAD® to Repair and Protect Cooling Water Pipeline

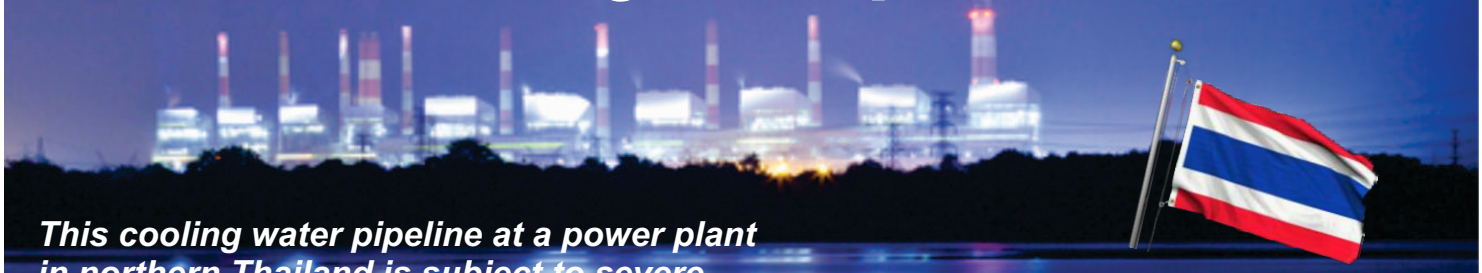
This cooling water pipeline at a power plant in northern Thailand is subject to severe erosion and corrosion due to water forced out by the fans located on top of the pipes as seen in the bottom left photograph.

The bottom half of the pipe (only 2 mm / .08 inches thick in some areas) was repaired using welded plates which were bonded to the pipe with CeramAlloy® CP+AC followed by two layers of CeramAlloy CL+AC.

The top of the pipe was coated with CHEMCLAD® SC as a cost saving measure.
