Russian Candy Factory Floor is Rehabilitated Using DuraQuartz, P4C & ENECLAD FPS.

Client: Russian candy factory.

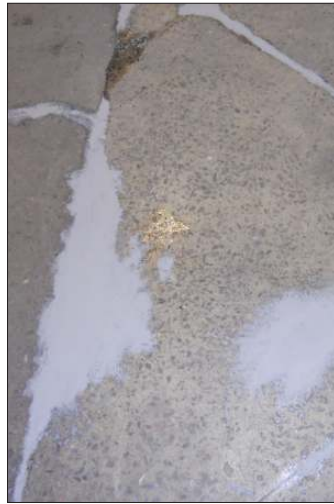
Problem: Concrete floor was severely cracked creating a safety hazard and potential damage to finished goods.

Solution: The floor was manually prepared and all loose material was removed. ENECRETE DuraQuartz was used to repair all cracks and voids. The floor was primed using CHEMCLAD P4C. Two coats of ENECLAD FPS were then applied. The client was delighted with the results.
