ELECON REVIS

This large gasoline tank located at one of the largest oil companies in the Philippines had been suffering from severe corrosion.

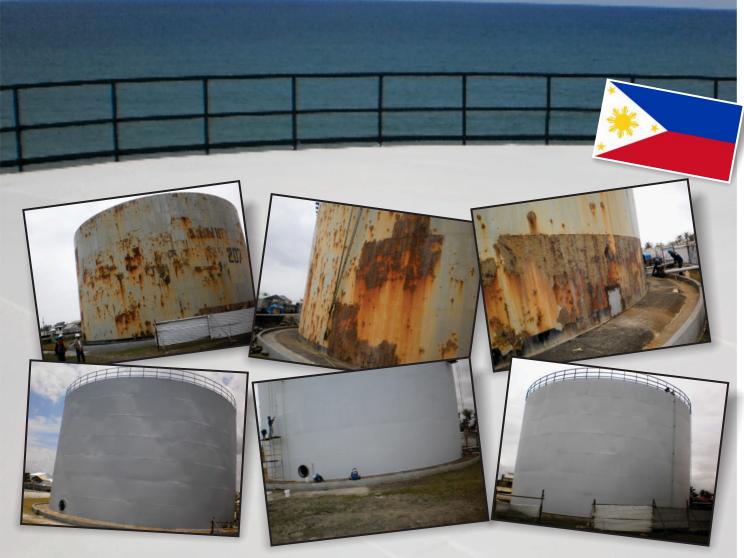
Previously the tank had been coated with an epoxy enamel that would last less than one year and would require touch-up

applications routinely.

The engineers called in the ENECON Philippines Field Engineering Team for help. It was decided that the tank would be cleaned with a combination of power washing and hand tools since grit blasting was not possible.

A two coat system of ENESEAL CR was then applied to provide long term corrosion protection.
