DuraWrap Repairs Power Plant Cooling Tower Supply Line

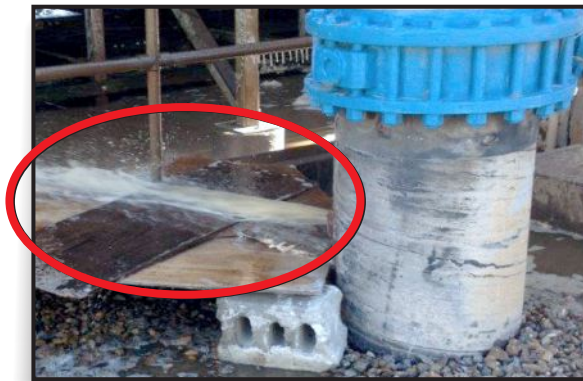
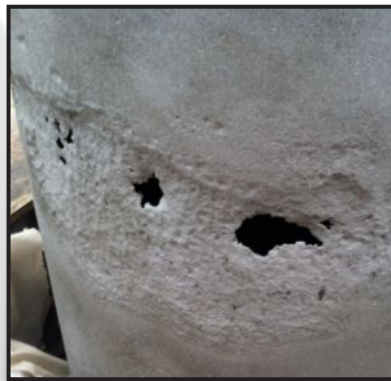
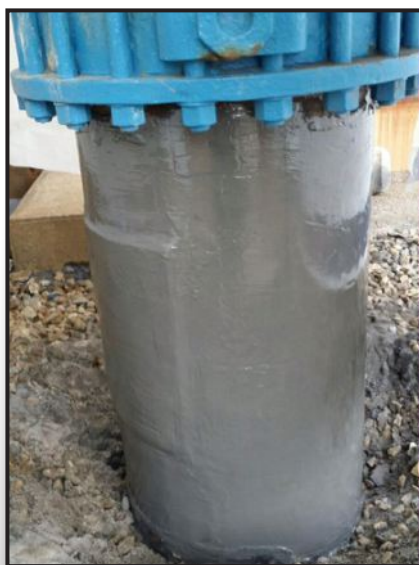
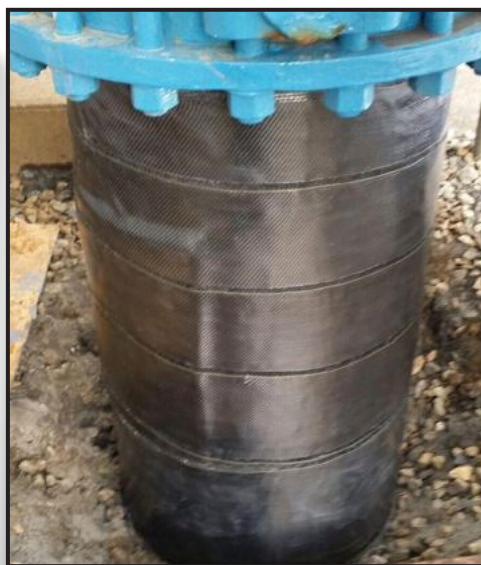
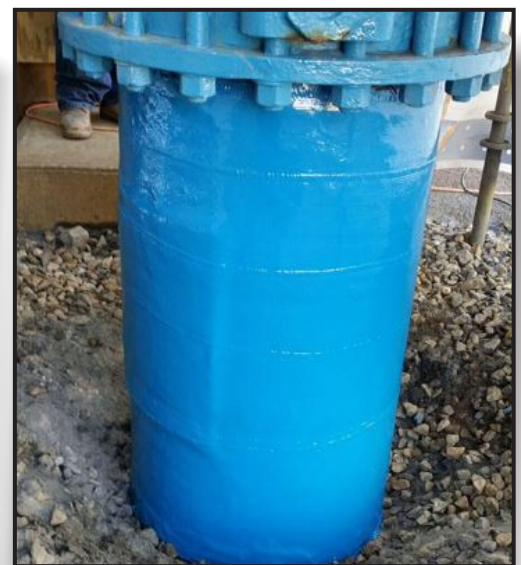
This 24 inch diameter intake pipe, located at a U.S. Power Plant, was leaking above the ground just below the disc valve. The plant's maintenance engineers needed a proven, reliable and economical solution to this problem.

The local ENECON Distributor was called in to develop a solution. First the exterior surface of the pipe was 'bristle blasted' to promote maximum adhesion by removing all existing failed coatings and corrosion.

Once the preparation was completed, a 12 x 12 x 1/8 inch thick curved steel plate was prepared and 'cold welded' over the holed area of the pipe using ENECON's DurAlloy.

That was followed by the application of two layers of the DuraWrap Carbon Fiber Pipe Wrap System. CeramAlloy CL+AC was then applied to the entire area as a final layer.
