## Russian Fire Station Floor Repaired With DuraQuartz & Protected With ENECLAD FPS

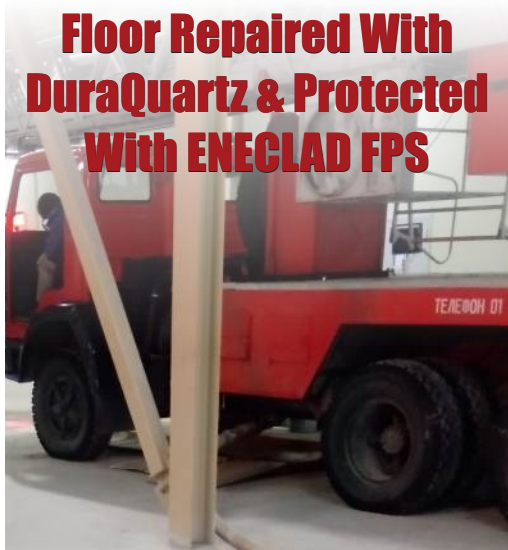
After being constructed and in service only 18 months, the protective coating on the floor of this Russian fire station failed. The concrete was absorbing oil and other liquids. The station operator needed a fast, durable and affordable solution.

The ENECON Distributor in Russia was contacted and proposed a complete resurfacing of the entire 5,800 sq. ft. floor.

First, a floor grinder was used to remove the failed, existing coating. Any necessary repairs to the concrete were made with DuraQuartz, then the entire floor was primed with ENECLAD CFS.

Two coats of ENECLAD FPS in Haze Gray were applied to the entire surface. To complete the intricate striping patterns needed in the fire station, a combination of CHEMCLAD GP in Safety Yellow and CHEMCLAD XC in White and Dark Gray were used.
