Geothermal Power Plant Uses CHEMCLAD[®]SC to Stop Corrosion on Waste Removal Trailers

Client: Geothermal power plant located in California.

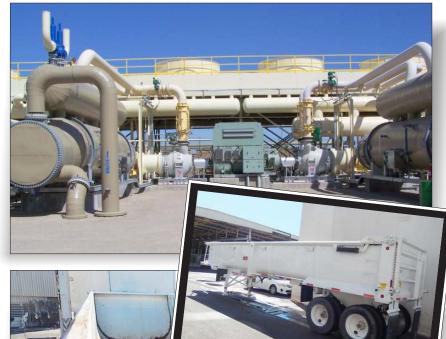
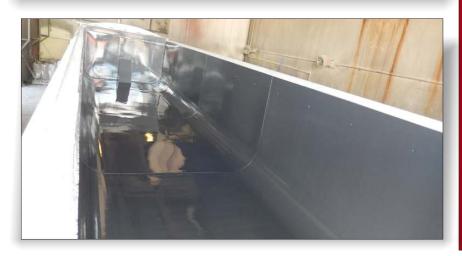
Problem: Corrosion to the steel beds of the trailers used to transport geothermal waste product (very salty brine mineral debris) to waste facilities.

Solution: Various conventional paints and liners had been used over the years and all of them had failed very quickly.

The trailer beds were grit blasted and two coats of CHEMCLAD SC were sprayed onto the 550 sq ft beds.
