CHEMCLAD SC Continues to Fight Corrosion on Waste Removal Trailers

CH-066

Geothermal Power Plant Uses CHEMCLAD SC to Stop Corrosion on Waste Removal Trailers

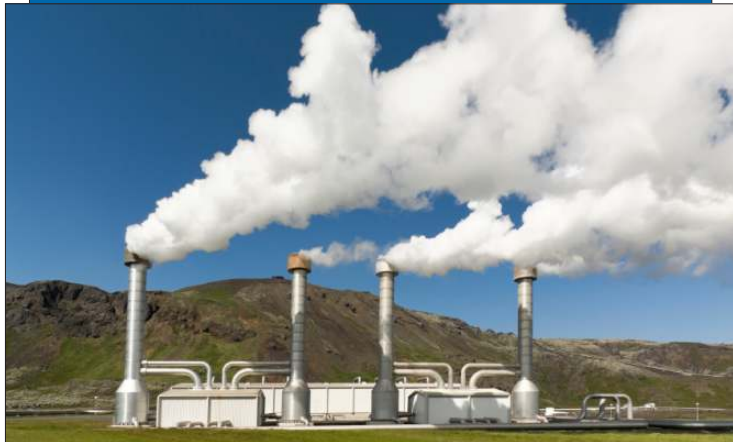
CHEMCLAD SC was used to protect new and used waste removal trailer beds used at a California geothermal power plant.

The trailer beds were grit blasted and two coats of CHEMCLAD SC were sprayed onto the 550 sq ft beds.

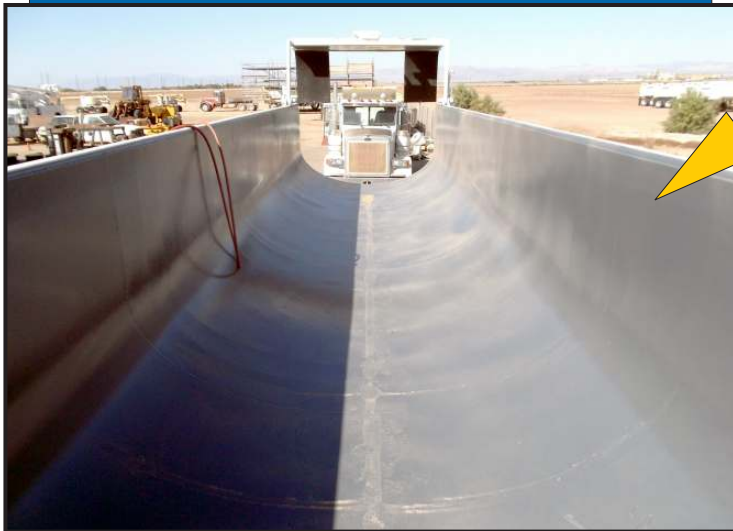
1 Year in Service and Counting... Still Looking Good

After one year in service transporting extremely corrosive brine mineral debris, the trailer beds are showing no signs of corrosion. Other products previously tried only lasted a few months.
