Hydroelectric Power Plant Repairs & Protects Francis Turbine with METALCLAD® & FLEXICLAD®

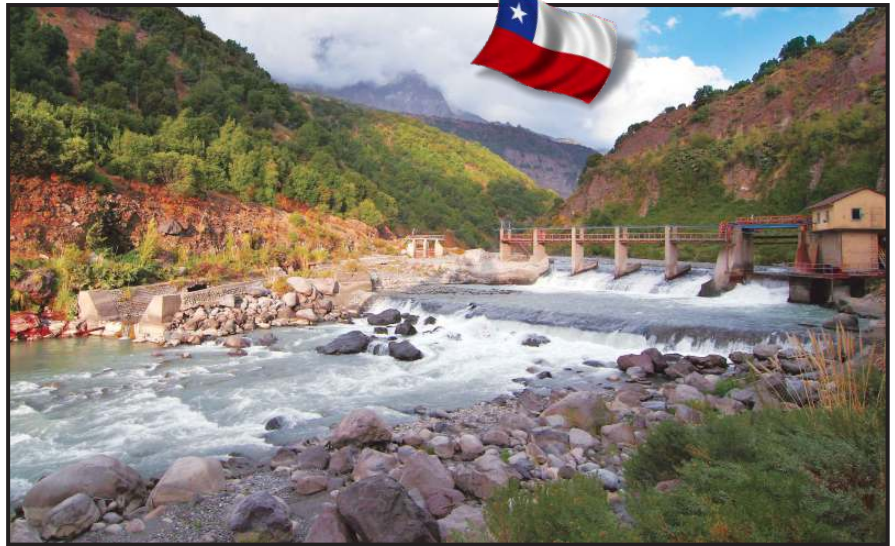
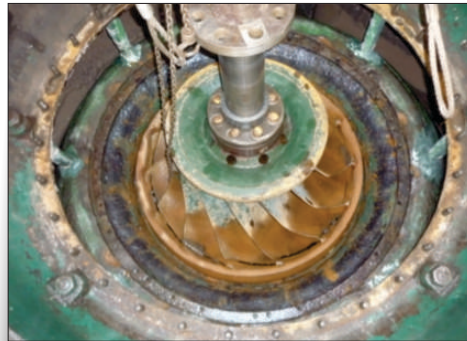
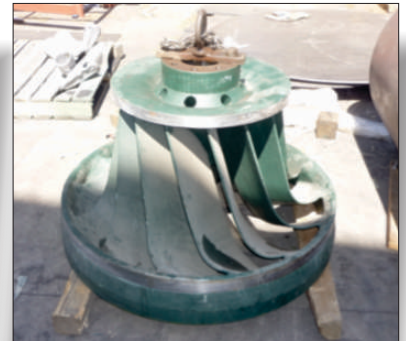
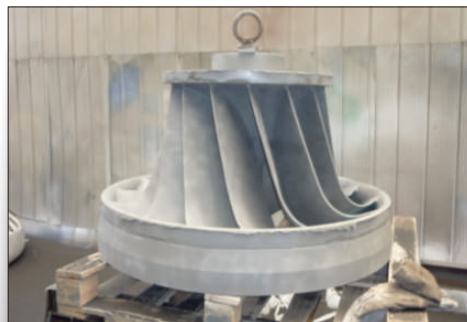
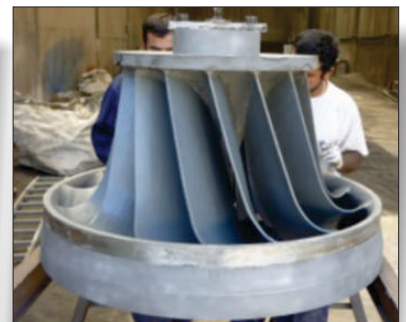
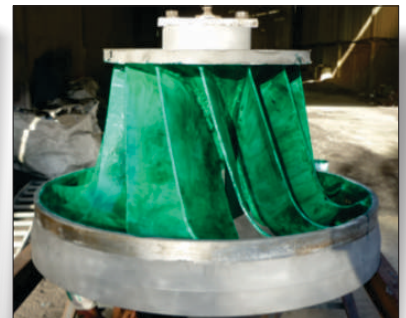
In a 54-year old hydroelectric plant near Santiago, Chile, major problems of erosion, corrosion and cavitation, made even more severe by a large amount of suspended solids, necessitated a complete refurbishment of this Francis turbine.

After cleaning and grit-blasting the turbine, METALCLAD CeramAlloy CP+AC was applied to rebuild all deeply eroded areas. CeramAlloy CL+AC was then used to resurface the turbine blades. Finally, the FLEXICLAD DuraTough DL system was used to protect all wet areas against cavitation as well as the abrasive action of the sand and silt in the river water.
