SuperBond & CHEMCLAD Eliminate Rust on U.S. Navy X-Class Ship's Hydraulic Piping System

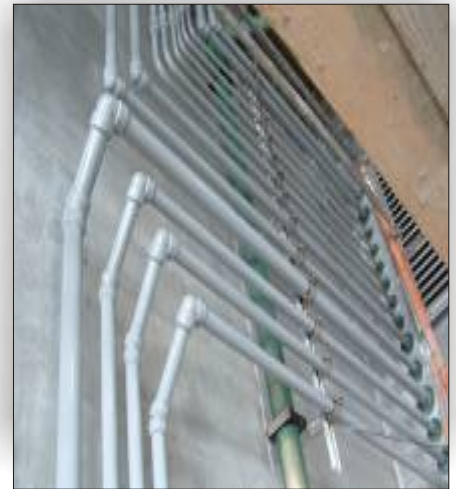
This new class of ship (twin hull, high speed catamaran) had been experiencing surface corrosion on the hydraulic piping in the aft of the ship from salt water spray. Excess rust and staining were a result.

by power washing were unsuccessful. The ship's CHENG (Chief Engineer) contacted the local ENECON Fluid Flow Systems Specialist and she recommended CHEMCLAD SC to solve this problem.

SuperBond followed by two coats of CHEMCLAD SC were applied. After several long journeys at speeds up to 60 knots, the CHEMCLAD System has performed flawlessly.

Repeated attempts to solve this problem After cleaning and sanding, one coat of
