ENECON Partners With Local Mechanical Engineering Company To Repair & Protect Cooling Tower

This 25 year old cooling tower located in downtown Seattle was built inside a structure with steel beams and a roof above it making it a very difficult candidate for replacement without involving major structural demolition and rebuilding.

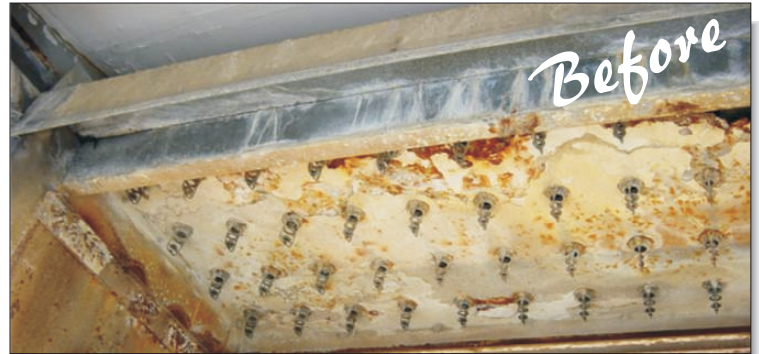
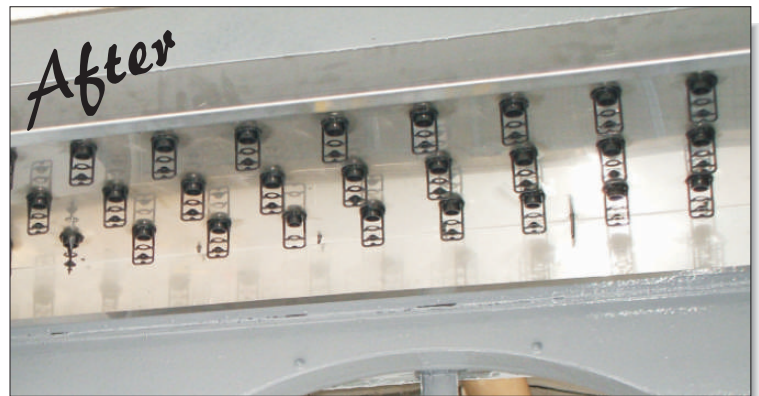
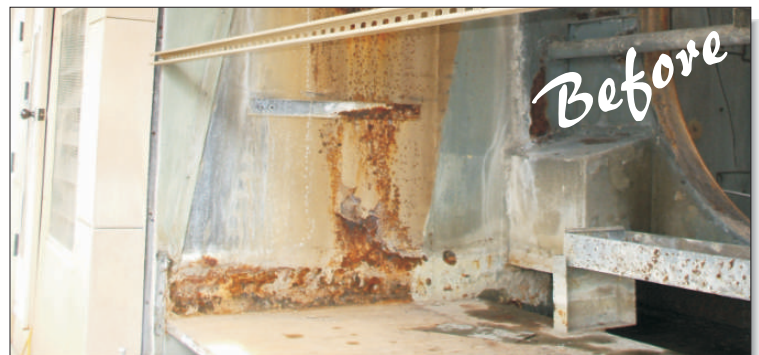
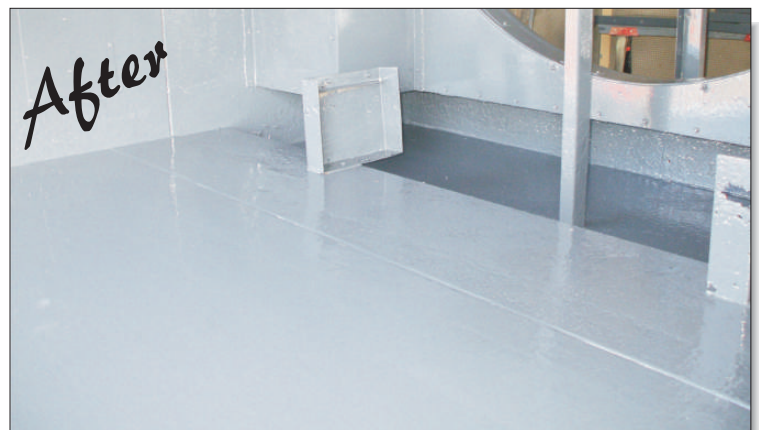
The interior of this cooling tower was grit blasted. The doubler plates were adhered in place then faired with DurAlloy. Two coats of CHEMCLAD SC were then applied. The fan shroud was coated separately with ENESEAL CR.

A local mechanical engineering company replaced the fill, strainers, nozzles, shaft, bearings, as well as fabricated and installed several new stainless steel replacement pieces.
