Spanish Navy Protects Cargo Deck with CHEMCLAD SC Non-Skid Safety System.

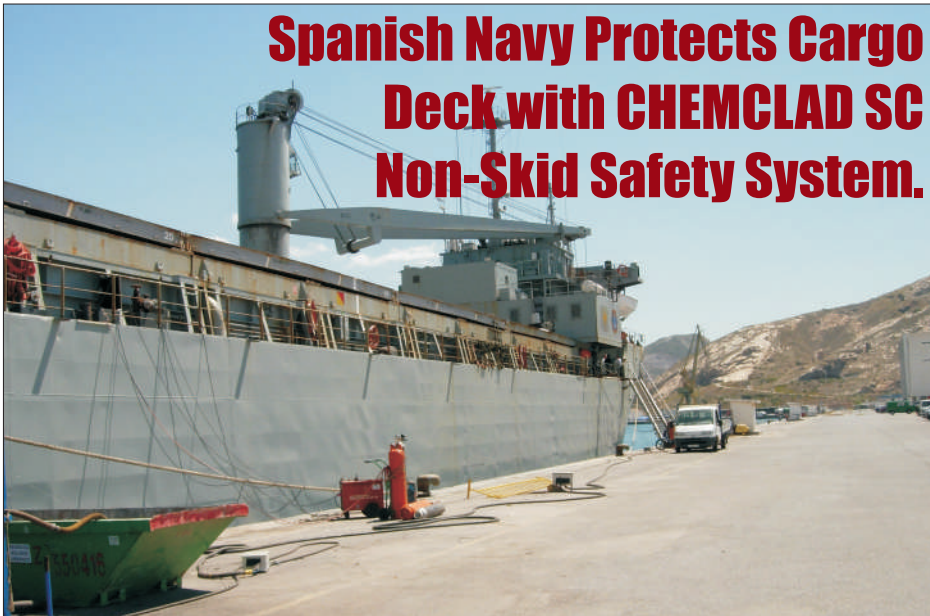
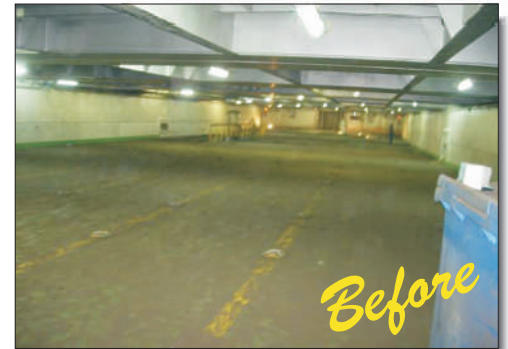
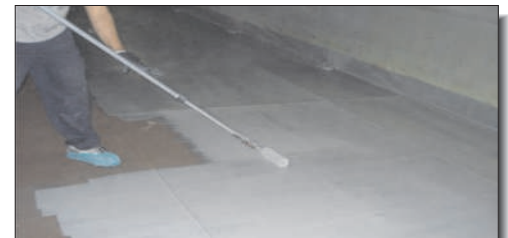
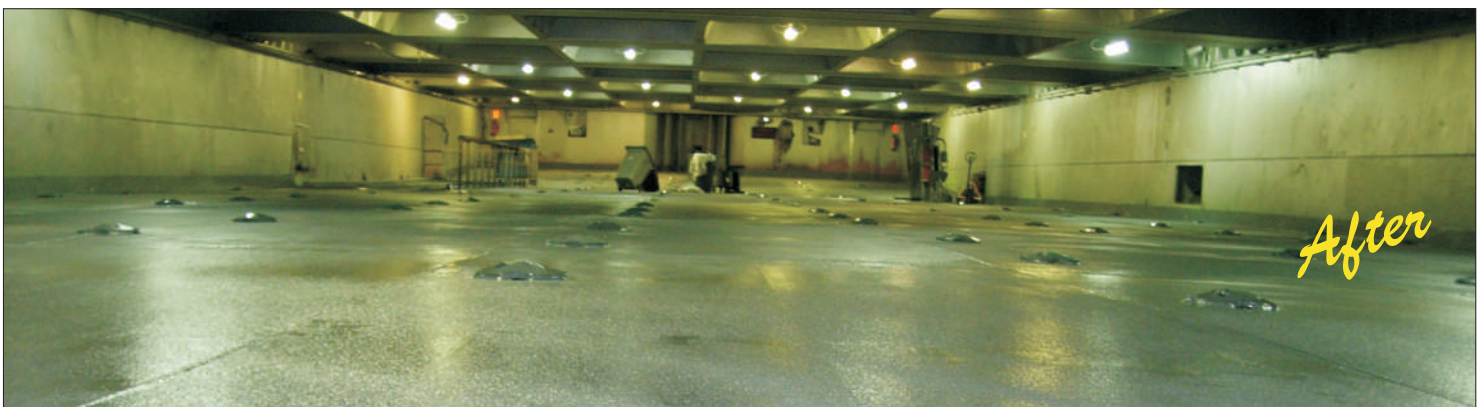
The hangar floor on this Spanish Naval vessel, used to transport tanks and other heavy vehicles, had been suffering from corrosion as a result of the failure of a conventional paint system.

The first coat of *CHEMCLAD SC* was rolled out. To provide slip-resistance, aluminum oxide aggregate was broadcast and back-rolled into the *CHEMCLAD SC* as it was applied.

A final topcoat of *CHEMCLAD SC* was then applied - giving the Navy a slip resistant,

easy to clean surface that would resist damage from gasoline, oil and hydraulic fluid while protecting the deck from corrosion for many years to come.

The ENECON Specialist recommended that a complete *CHEMCLAD SC System*, incorporating aluminum oxide aggregate to provide slip-resistant safety surfacing, be applied to protect this floor from further corrosion damage.
