ECON REVS

Client: **Power Plant**

Location: Chile

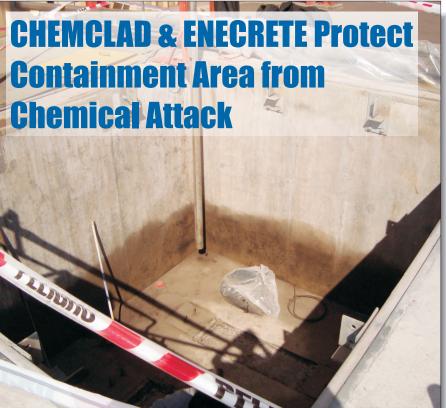
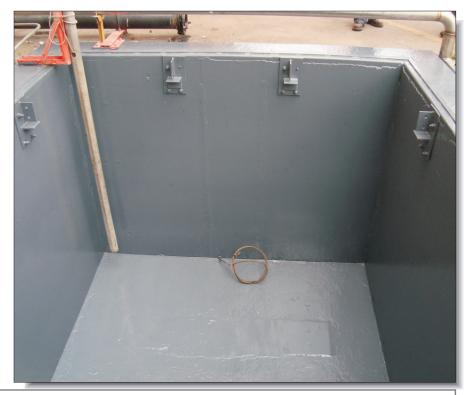
Concrete containment area was suffering from chemical attack and corrosion after prolonged exposure to oil and fuel spillage.

After removing contaminated concrete and thoroughly cleaning, ENECRETE DuraQuartz was used to repair the concrete walls.

CHEMCLAD SC was then used to protect the concrete from future corrosion.
