DuraQuartz Stands Up to Forklift Traffic... 17,280 Times a Week!

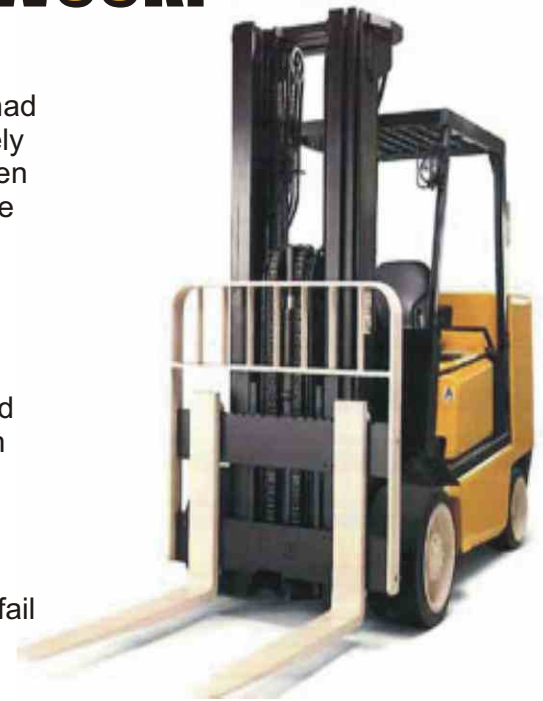
The facility attempted to repair the problem several times using various quick-set concrete repair materials. Each of these repairs would fail very quickly when exposed to the constant forklift traffic.
