## Seattle Office Building Steps are Repaired with ENECRETE DuraQuartz

**Client:** Commercial office building

**Location:** Seattle, WA

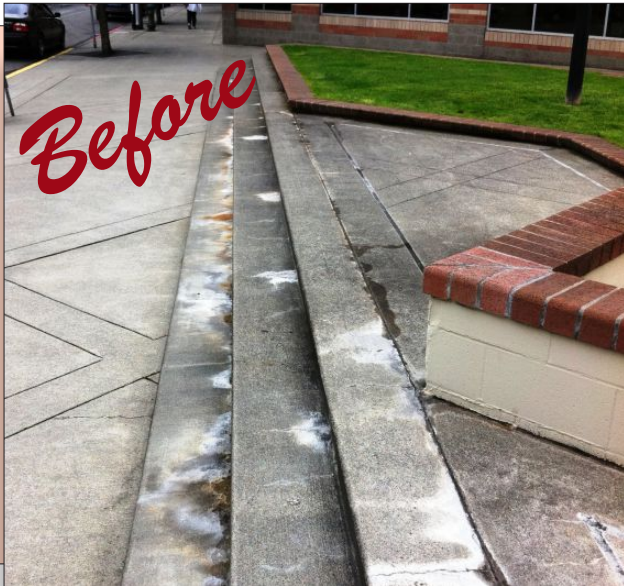
**Problem:** High traffic main entrance steps were unsightly and beginning to deteriorate causing a potential tripping hazard. This entrance could not be shut down and sidewalk pedestrians could not be adversely effected by any repair process.

**Solution:** This \$20,000+ project began with dry ice blasting, completed in the unpredictable Seattle weather, to clean the steps prior to application. ENECRETE DuraQuartz with a customized broadcast system was then used to re-build the steps, create slip-resistance and protect them from future deterioration.
