ENECLAD FPS 2000 Revitalizes Main Entrance For This Pennsylvania Manufacturer

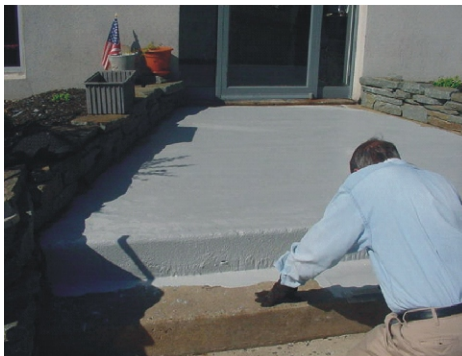
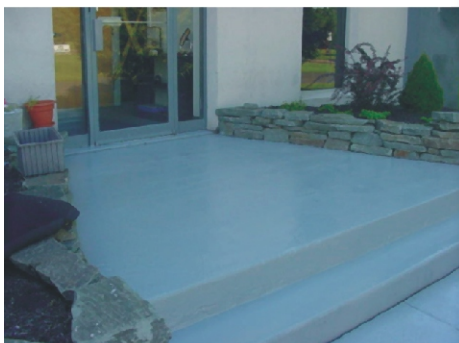
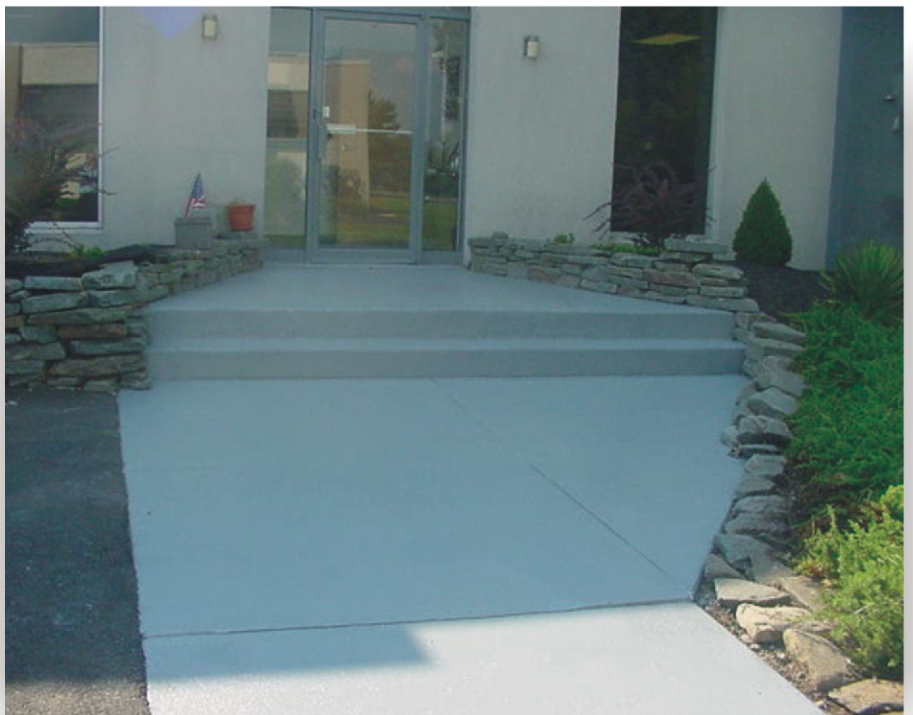
The main entrance for this manufacturing company was showing its age. The concrete was cracked and deteriorated. The conventional approach would have required removing the old concrete and pouring new steps and walkway. The corresponding downtime would have presented problems since this entrance was the main access to the facility.

The concrete was first power washed and allowed to dry. DuraQuartz was used to repair all the cracks and heavily damaged areas. ENECRETE Self Priming Screed (SPS) was then applied to smooth out the rough

concrete surface. Finally, two coats of ENECLAD FPS 2000 were installed by roller and a #46 aluminum oxide aggregate was 'back-rolled' into the topcoat to provide for a safety, non-slip surface. This project was accomplished in just two days to the complete satisfaction of the building owners.
