ENESEAL Improves Cooling Tower Efficiency While Adding Corrosion Protection at Meat Packing Plant

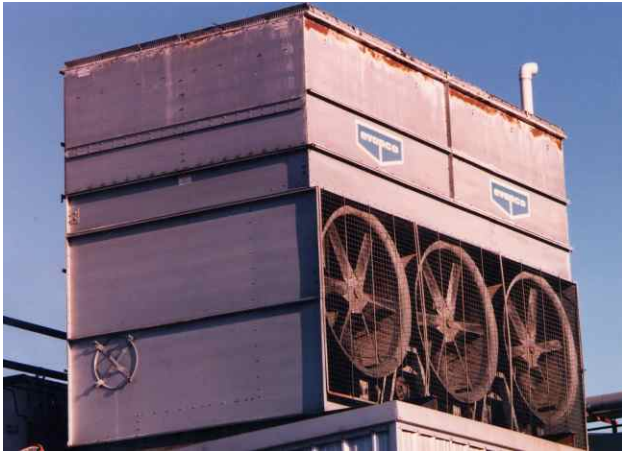
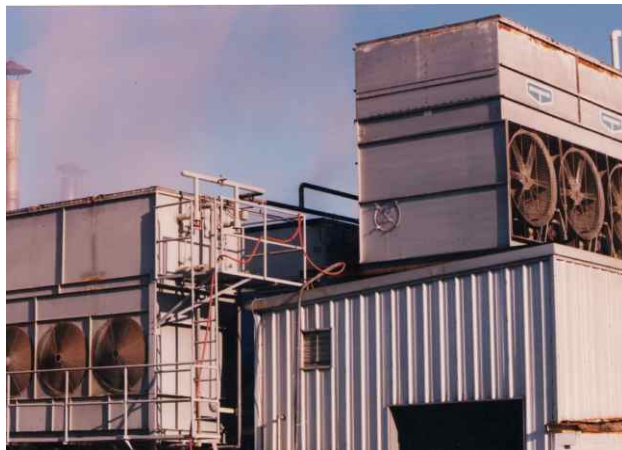
The original galvanized metal on the units, both measuring 8 feet by 1 foot and standing 15 feet high, had weathered over the years and had become very dull - resulting in efficiency losses to the system. In addition, there was some localized corrosion damage along the top edges due to a fine mist always present in this area.

The units were first blasted, removing all rust down to bare metal. After priming these areas, two coats of the ENESEAL HR were applied using 45:1 Bulldog Airless Spray equipment.

The units were coated during a warm period of the fall with daytime temperatures around 80° (27° C). As the coating of different sections was completed, the plant engineers were amazed at the appreciable temperature difference they could feel with their bare hands between untreated sections and the areas already coated with the ENESEAL HR.
