ENECON® NEWS

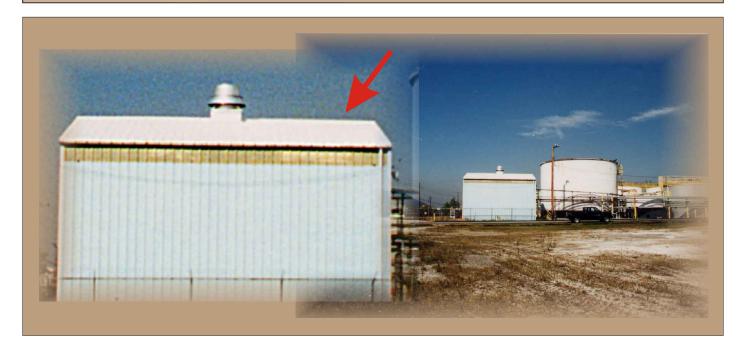
The director of maintenance at this major chemical company in western Pennsylvania was very concerned about the remaining life expectancy of this metal roof which was about 50% covered with rust. The cost of replacing this roof in the next few years was not in the budget.

The roof was first pressure washed and a rust inhibiting primer, supplied by the plant, was applied to the roof surface. Two coats of ENESEAL HR were then applied by airless spray over the entire roof area.

The ENESEAL not only eliminated the rusting problem; it also sealed numerous pinholes in the roof, lowered the ambient temperature in the building during the hot summer months, and greatly enhanced the image of the building.
