## Town Park Uses DuraQuartz & ENESEAL to Repair & Protect Concrete Ceiling

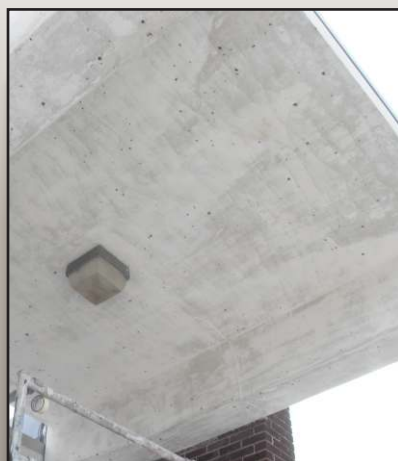
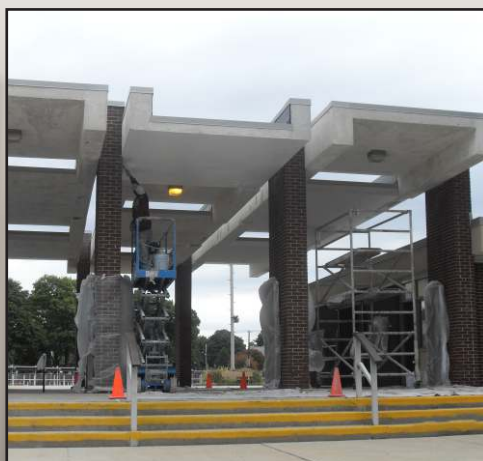
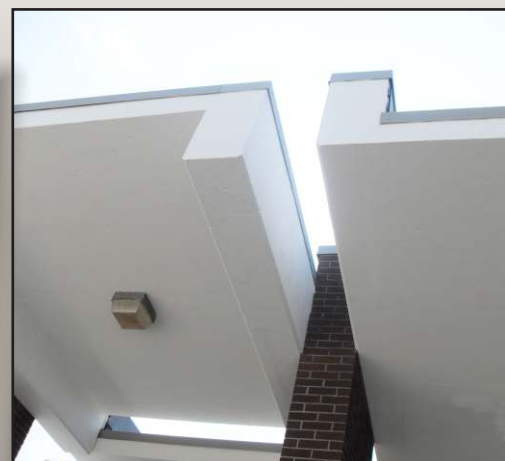
**Problem:** The park's entrance ceiling was showing signs of water damage, spalled concrete, exposed rebar and missing failed coating. The Town was concerned that loose concrete could create a safety issue for park users.

**Solution:** A combination of power washing and hand grinding was used to thoroughly clean the surface and remove any loose concrete. Any exposed rebar was coated with **ENESEAL CR** and all damaged concrete areas were repaired with **ENECRETE DuraQuartz** with *light weight aggregate*. **ENESEAL HR** was used as a final topcoat.
