US Aircraft Carrier Solves Condenser Problems With ENECON CeramAlloy...

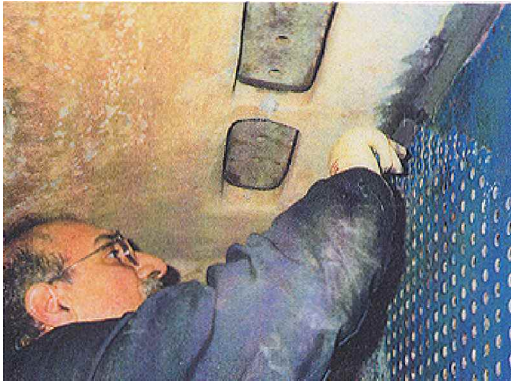
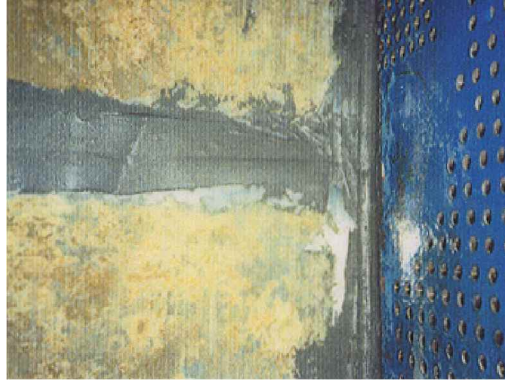
Engineers on the USS Forrestal (CV-59), undergoing repairs at the Philadelphia Naval Shipyard, had been concerned about some leaks between the water boxes and the tubesheets on their main steam condensers.

The Design Division at the Shipyard called in the ENECON Engineering Team. CeramAlloy was used to seal all the joints and seams on the condenser.

All surfaces were thoroughly cleaned and roughened. ENECON CeramAlloy was then applied to completely encapsulate and seal these critical areas and to protect them from the aggressive sea water.
