CeramAlloy Wrapping Procedure Protects Marine Tail Shafting -- Outperforms Traditional Systems Such as Fiberglass & Conventional Epoxies

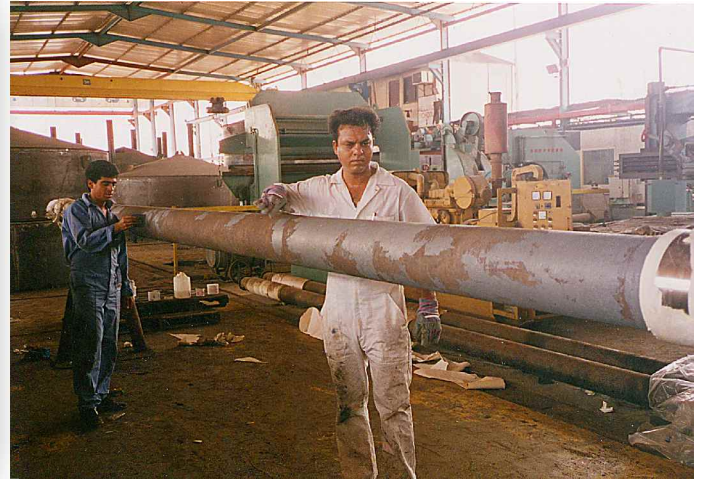
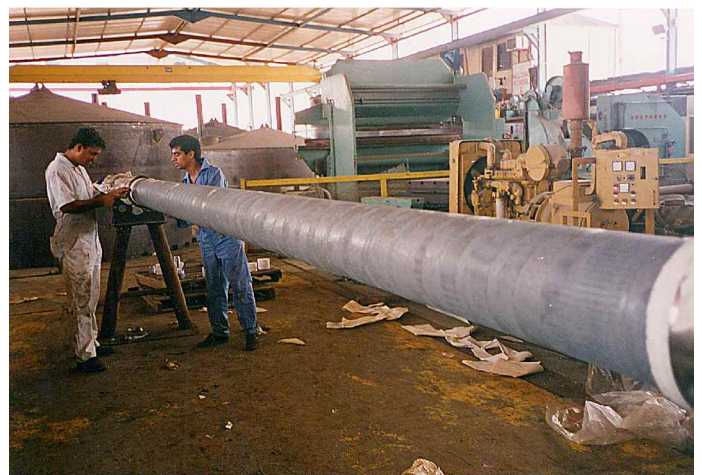
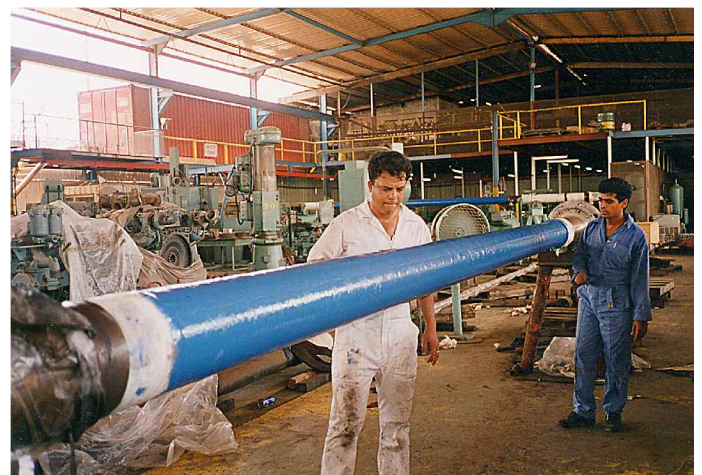
This application at a local shipping company illustrates the effectiveness of CeramAlloy used to repair and then protect

exposed marine tail shafting.

After the shaft was grit blasted, CeramAlloy CP+ was used to fill-in and repair all pitted areas on the shaft.

Then 2 layers of CL+ liquid ceramic were installed utilizing ENECON reinforcing sheet as a wrap between coats of the CeramAlloy CL+.
